FCP Short Course

Fracture Case Studies

Stephen D. Downing
Mechanical Science and Engineering

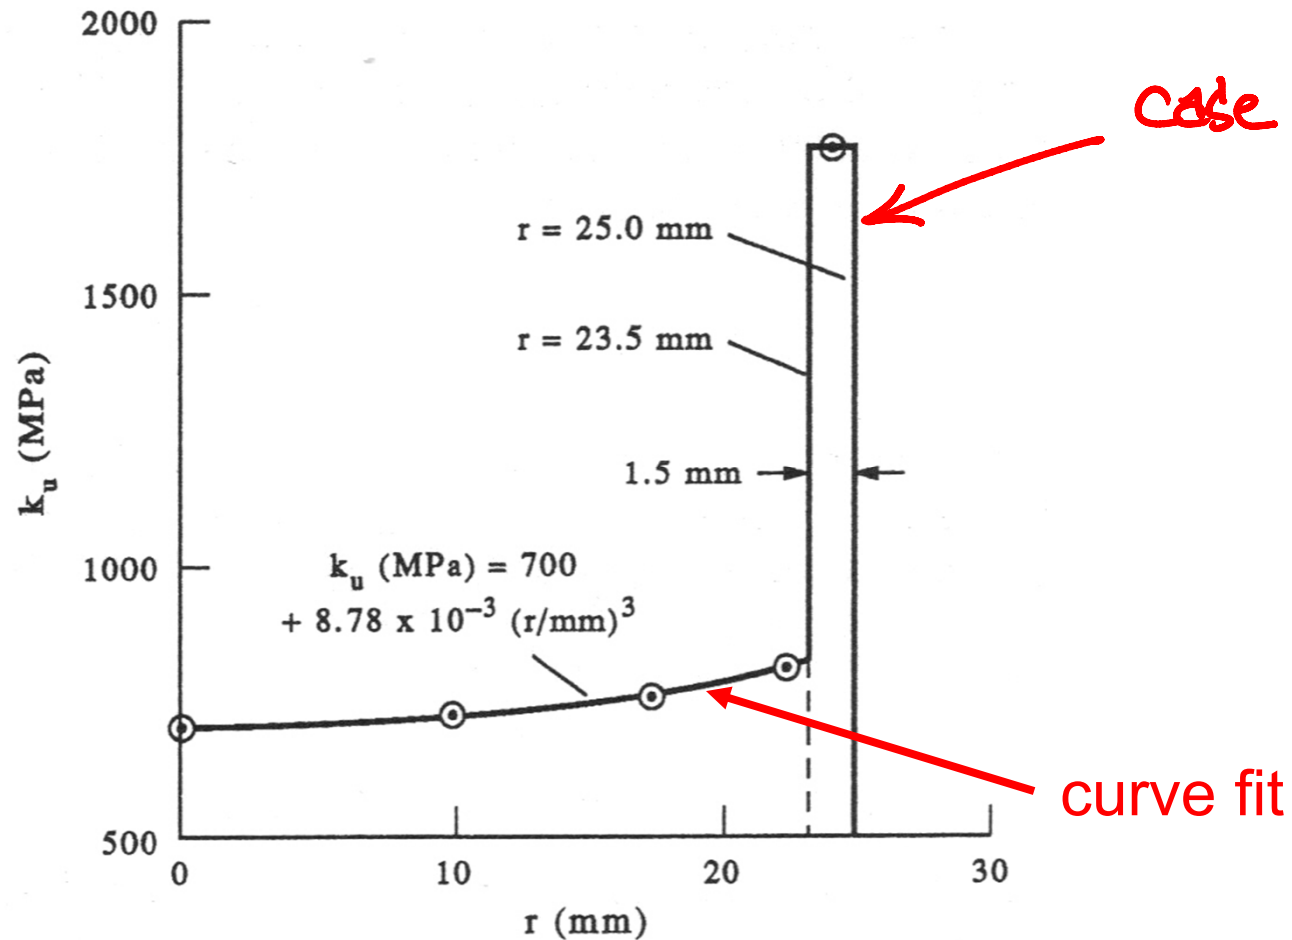
Steering Shaft

Shear stress vs. radial distance from shaft center

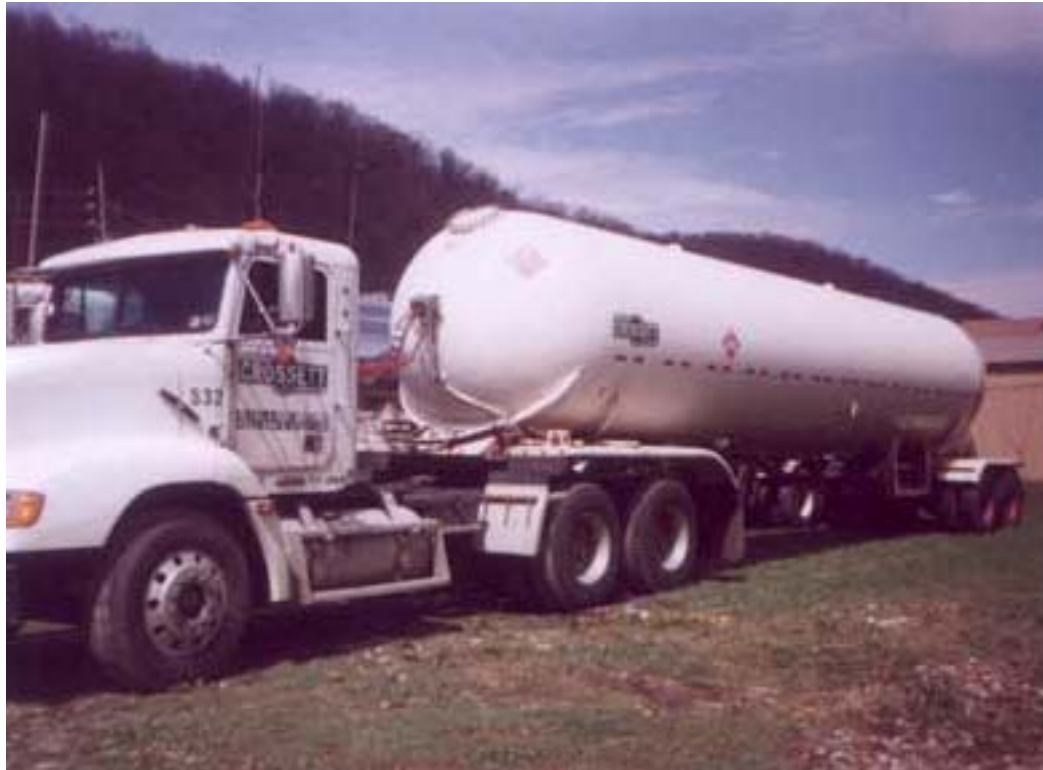
Similar Tanker Truck

- Fast fracture in circumferential weld
 - End cap blown off (serious mayhem)
 - Unloading (decanting) process
 - Space above liquid is pressurized with ammonia gas with compressor
 - $P_{\text{compressor}} = 1.83 \text{ MPa}$
 - Safety valve set at 2.07 MPa
- } should be safe

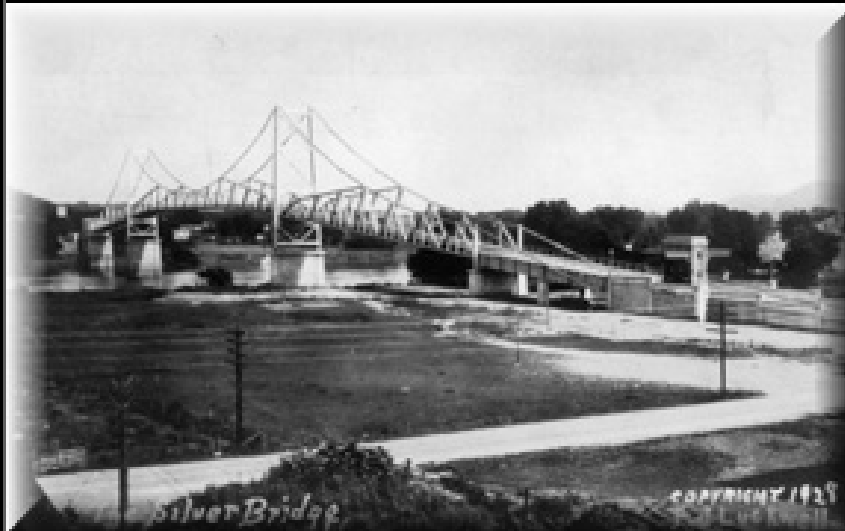
Silver Bridge

19 May 1928

- Completed 19 May 1928
- Connects
 - Huntington, VA to Middleport, OH
 - Charleston, VA to Dayton, OH
- Major east-west connection for US Route 35
- Two lanes of automobile traffic
- 1750 feet in length
- Steel Eyebar Suspension Bridge
- Aluminum Paint (“Silver Bridge”)

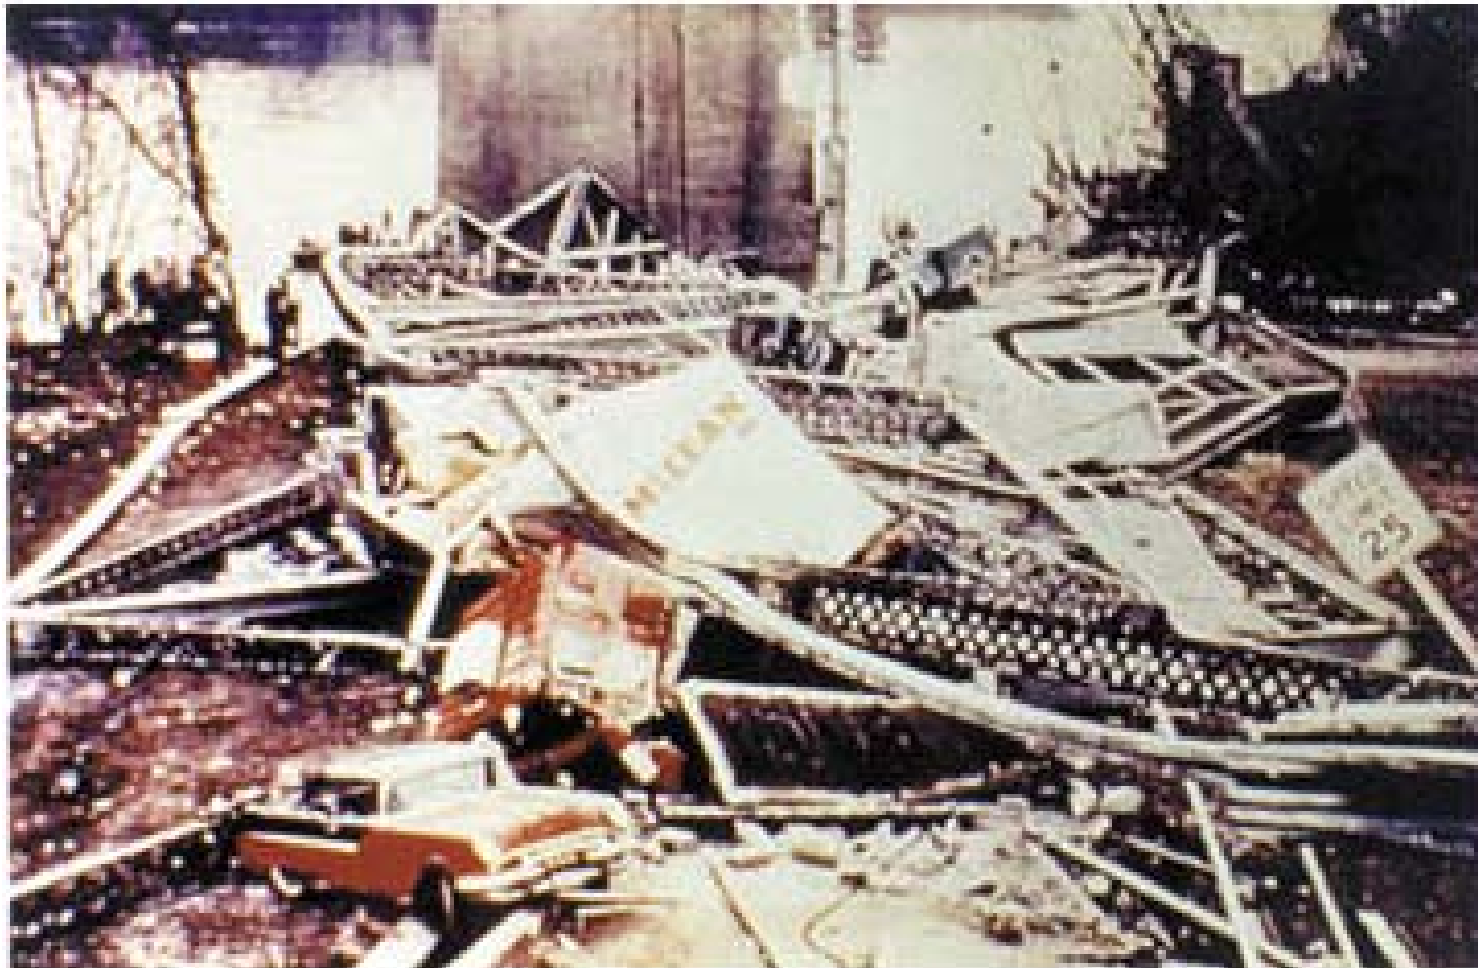
Failure Evidence

Debris from the collapse of the Silver Bridge on Dec. 15, 1967.
