FCP REPORT NO. 1

ANALYSIS OF FAILURES IN METAL COMPONENTS

Thomas J. Dolan

FRACTURE
CONTROL
PROGRAM

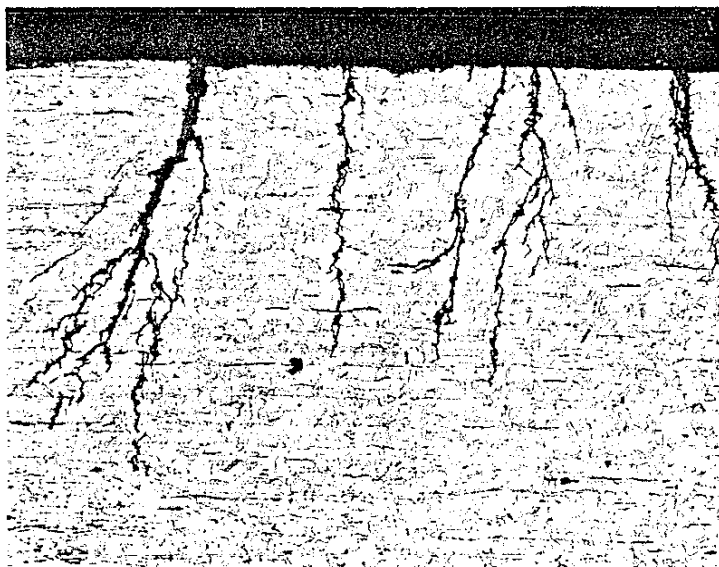
Fig. 8 Expansion Joint in a Steam Distribution Line. Failure was traced to corrosion fatigue resulting from stresses caused by thermal cycling and a hostile environment due to dripping condensate. Photomicrograph at 100 X of type 304 stainless sheet steel.

fatigue as in Fig. 8, or by stress corrosion cracking because of environmental conditions and the unknown residual, or shakedown stresses developed by fabrication procedures, or by service loads.

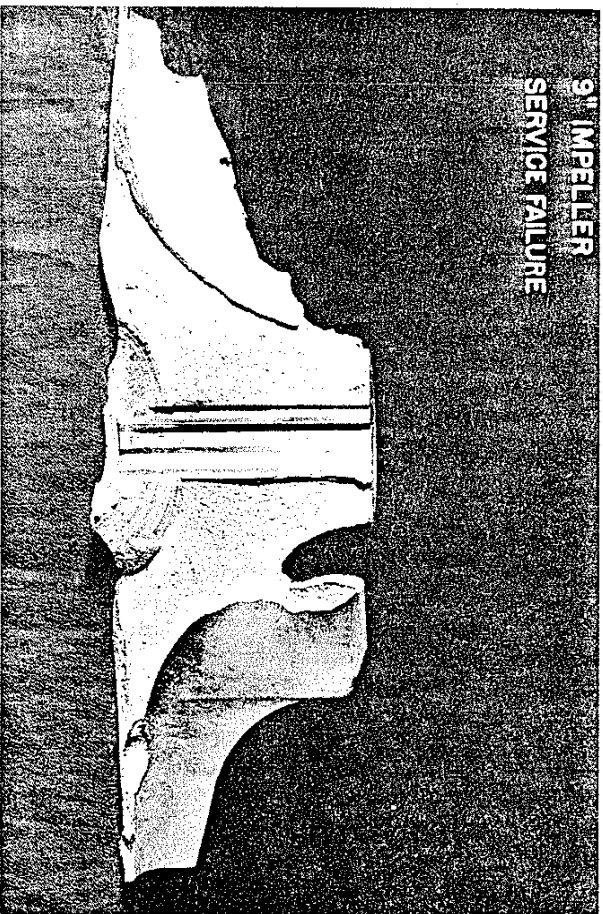
Fig. 20 Failure of Die-Forged Super Charger Driven Through a Splined Shaft.

Exhaust impulses led to torsional vibrations causing fatigue crack which developed to critical size for brittle fracture of the rest of the impeller.
