UILU-ENG 91-3601

Report No. 155

**FATIGUE OF ALUMINA
AT ROOM AND HIGH TEMPERATURES**

A Report of the
MATERIALS ENGINEERING—MECHANICAL BEHAVIOR
College of Engineering, University of Illinois at Urbana-Champaign
October 1991

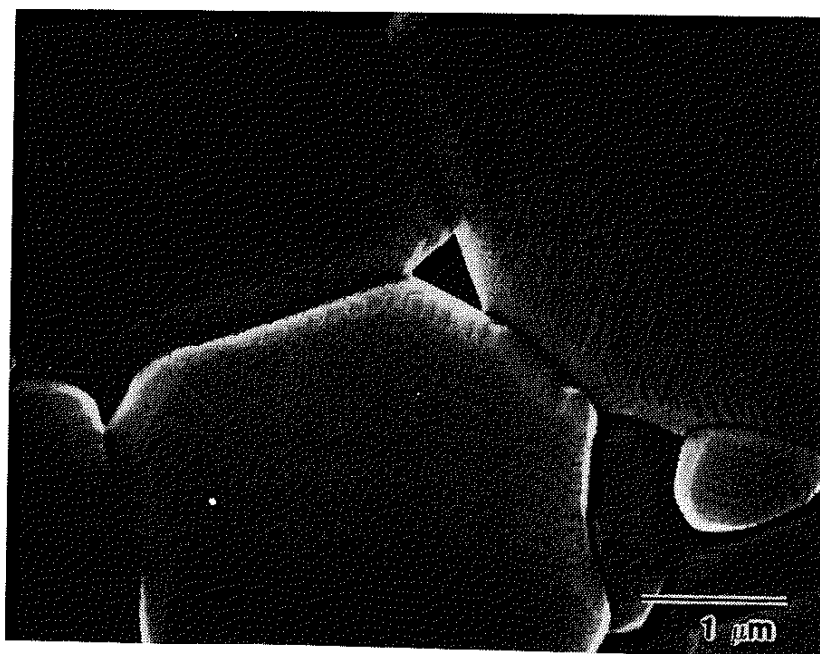
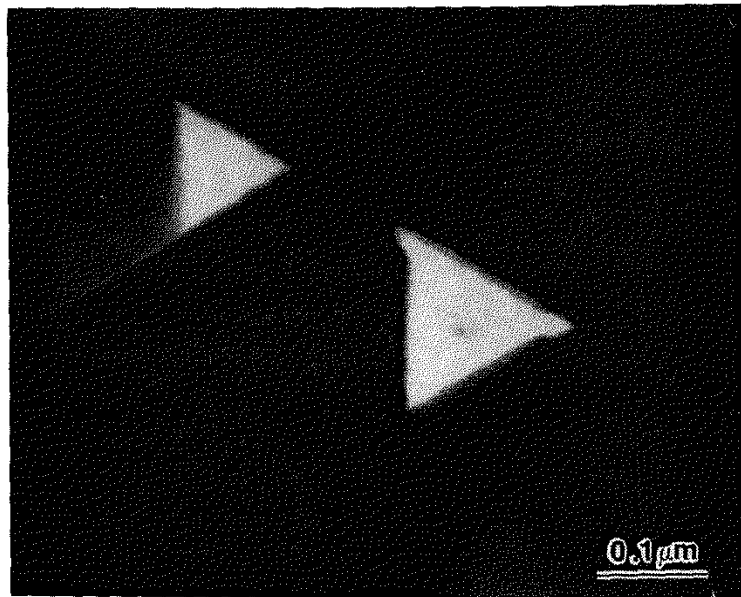
Figure 17 SEM micrographs of the as-received microstructure for the AD-998 alumina showing the residual porosity. (A) low magnification view and (B) high magnification view.

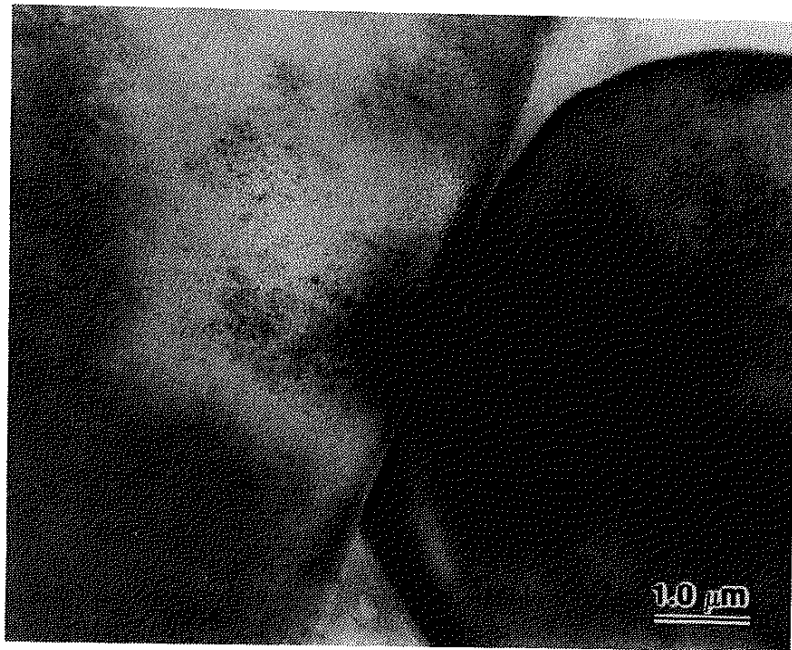
Figure 18 Diffuse dark-field TEM micrographs of the as-received alumina illustrating the isolated zones of glassy phase (A) at triple-point junctions, (B) at a two-grain "channel", and (C) along a two-grain interface and connected triple-point junctions. The glassy phase appears bright in the diffuse dark-field image.

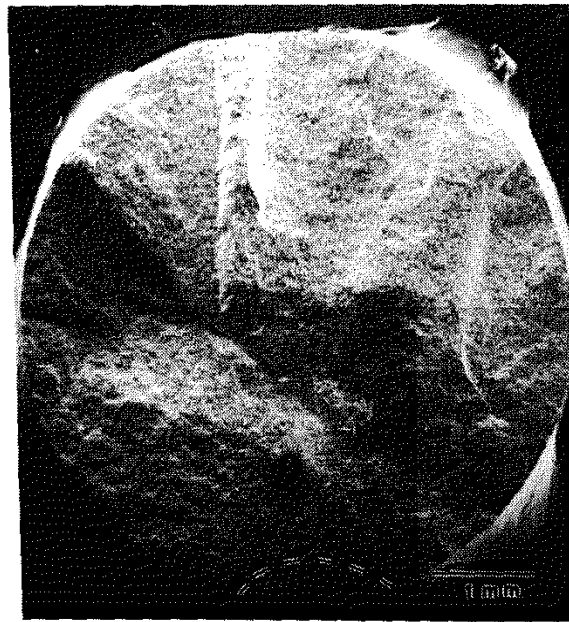
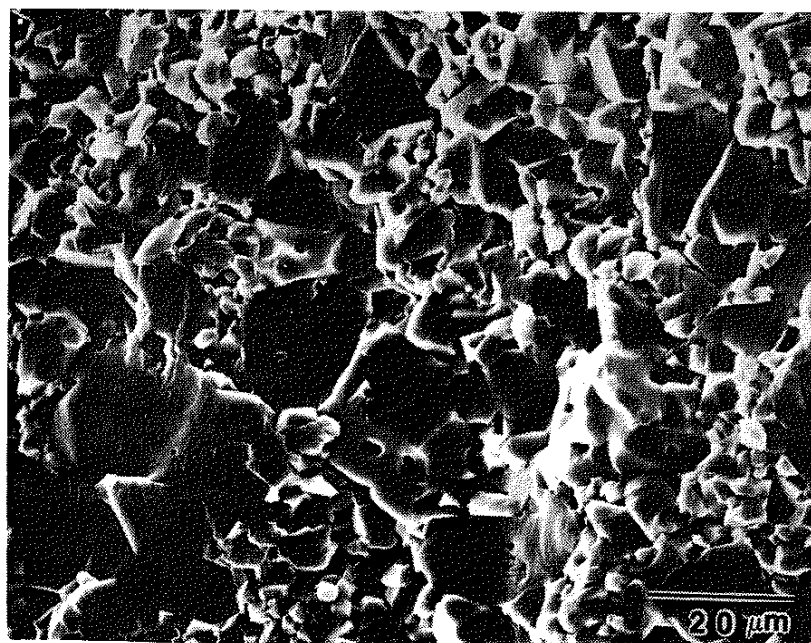
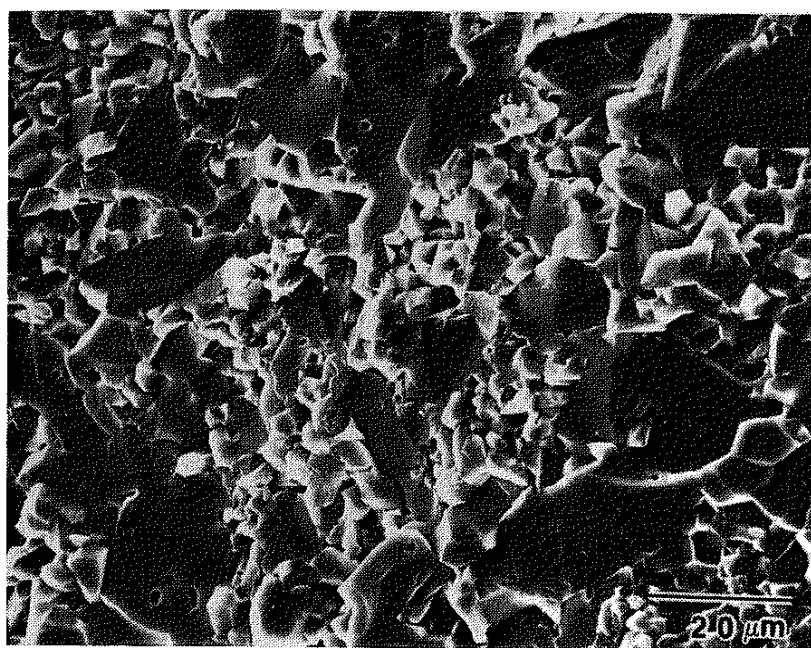
Figure 19 SEM micrographs demonstrating the typical fracture surface in cyclic fatigue specimens failed at room temperature. (A) macroscopic view, (B) high magnification view in the slow crack growth region, (C) high magnification view in the fast fracture zone. ($\sigma_{\max} = 220.6$ MPa, 2 Hz)

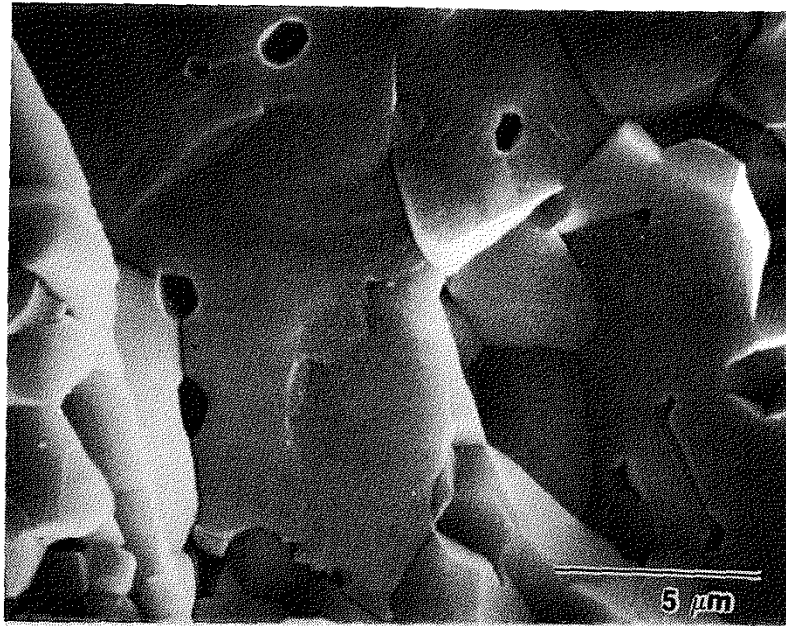
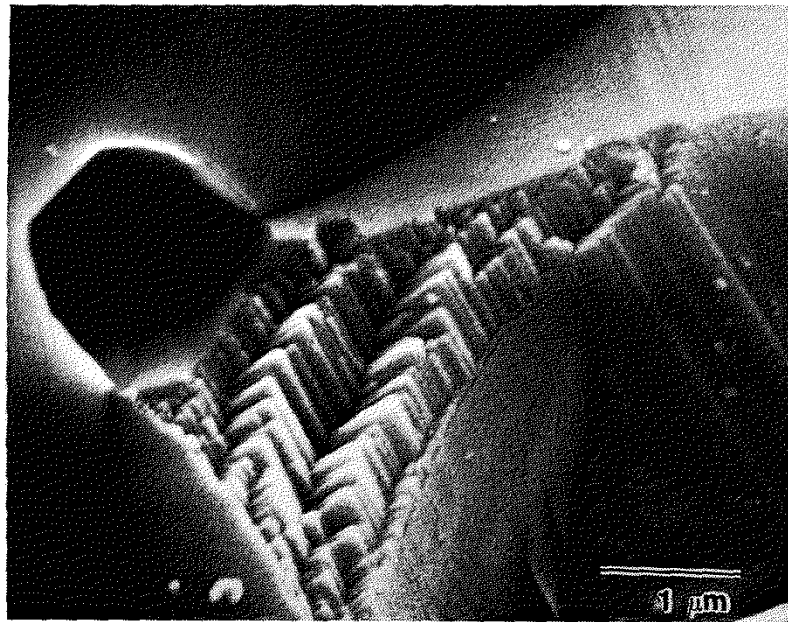
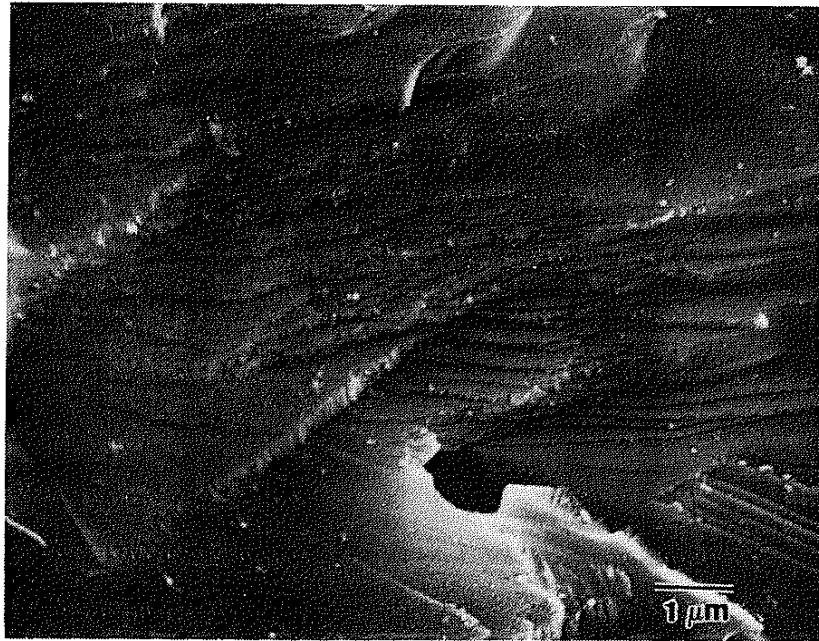
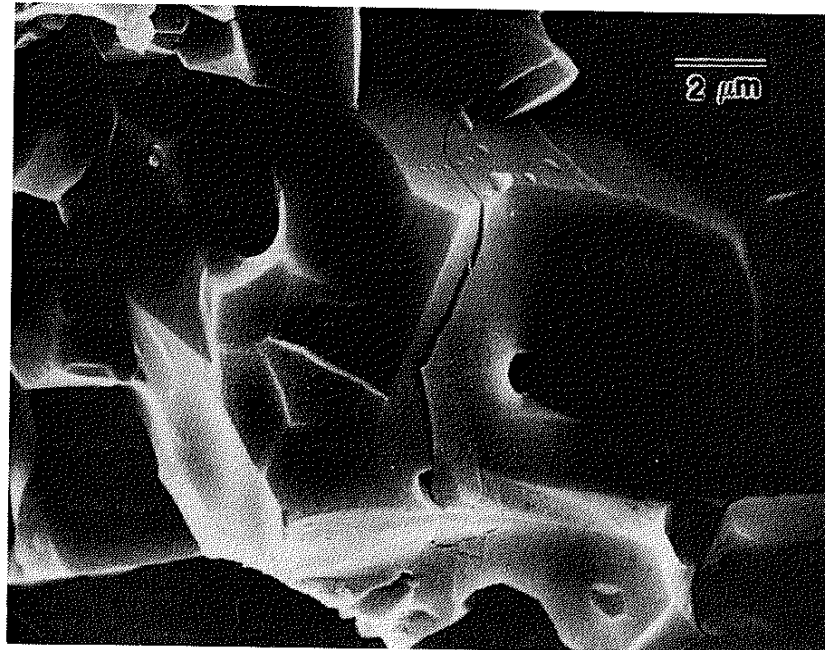
Figure 20 SEM micrographs of some typical features of transgranular failure mode observed in the fracture surface of room temperature specimens. (A) general view, (B and C) higher magnification view of the cleavage facets associated with the grain-boundary pores or within-grain pores, and (D) a transverse crack through the grain facet.

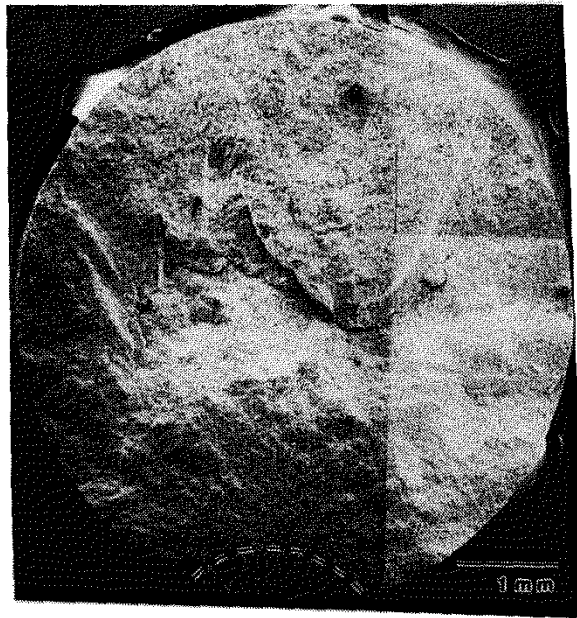
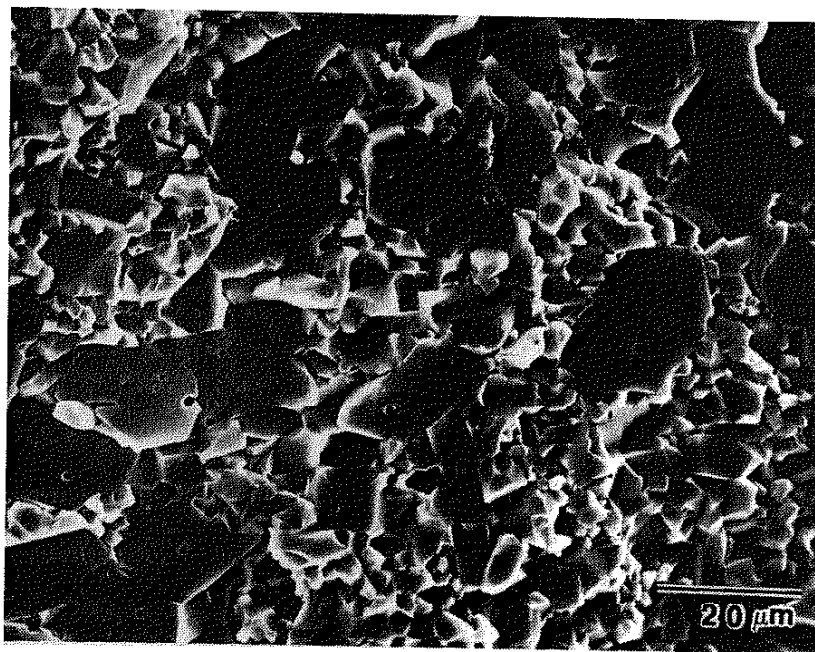
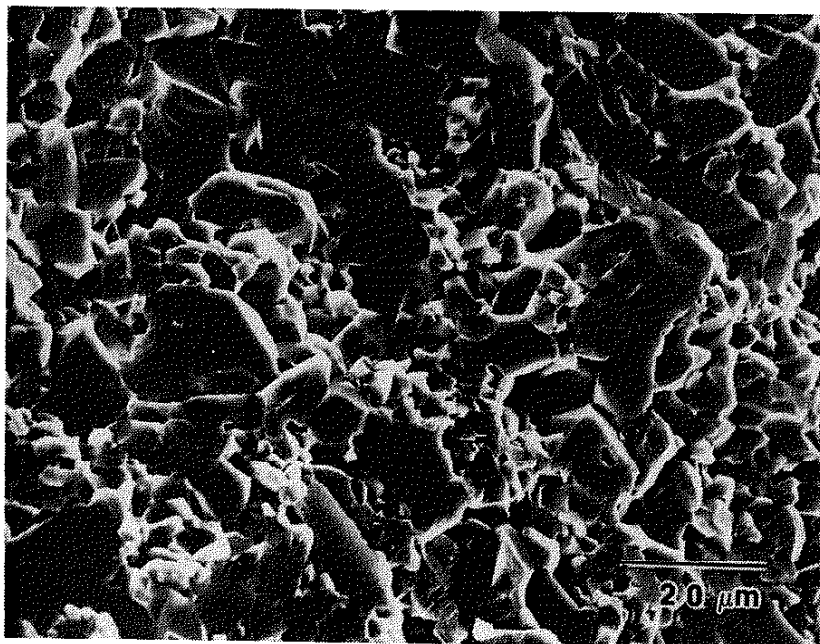
Figure 21 SEM micrographs demonstrating the typical fracture surface in static fatigue specimens failed at room temperature. (A) macroscopic view, (B) high magnification view in the slow crack growth region, and (C) high magnification view in the fast fracture zone. ($\sigma_{\max} = 234.4 \text{ MPa}$)

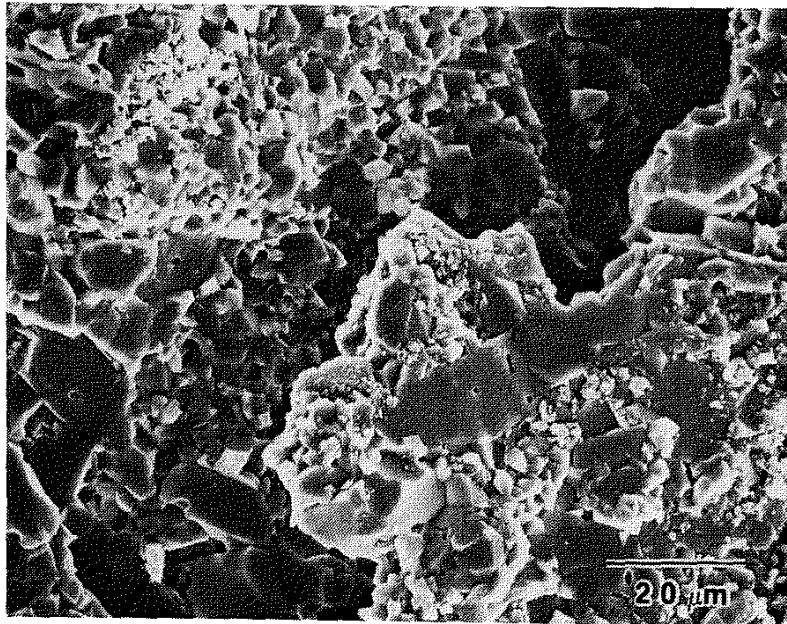
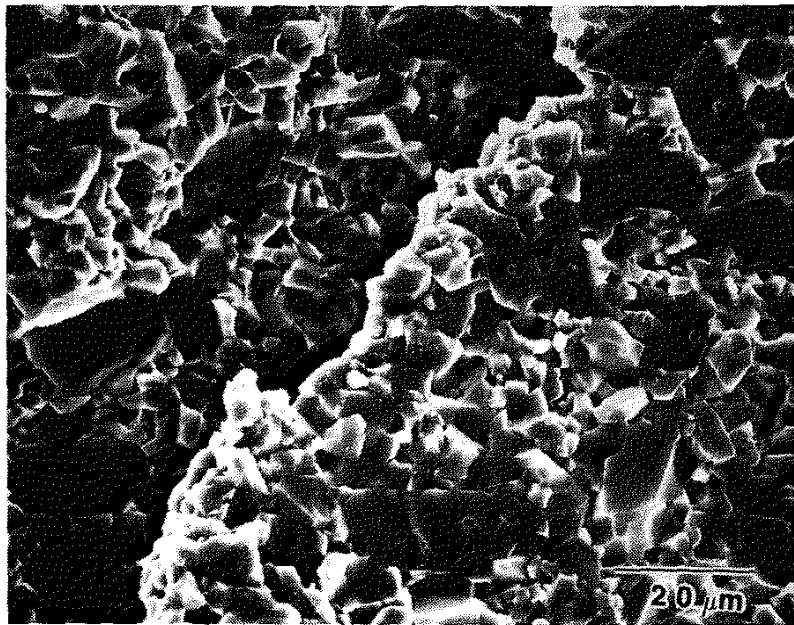
Figure 22 Debris formation observed around the macrocrack branching areas on the fracture surface in both (A) static fatigue and (B) cyclic fatigue specimens failed at room temperature.

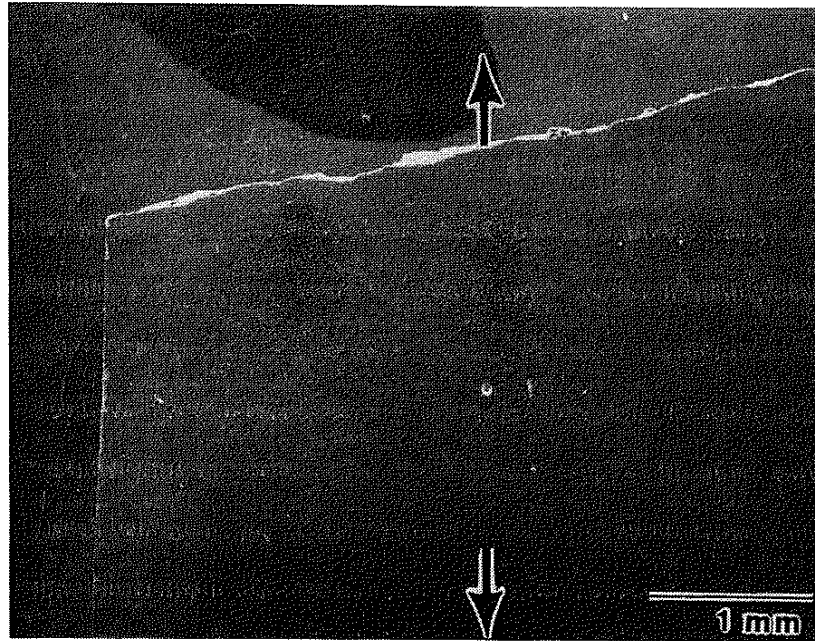
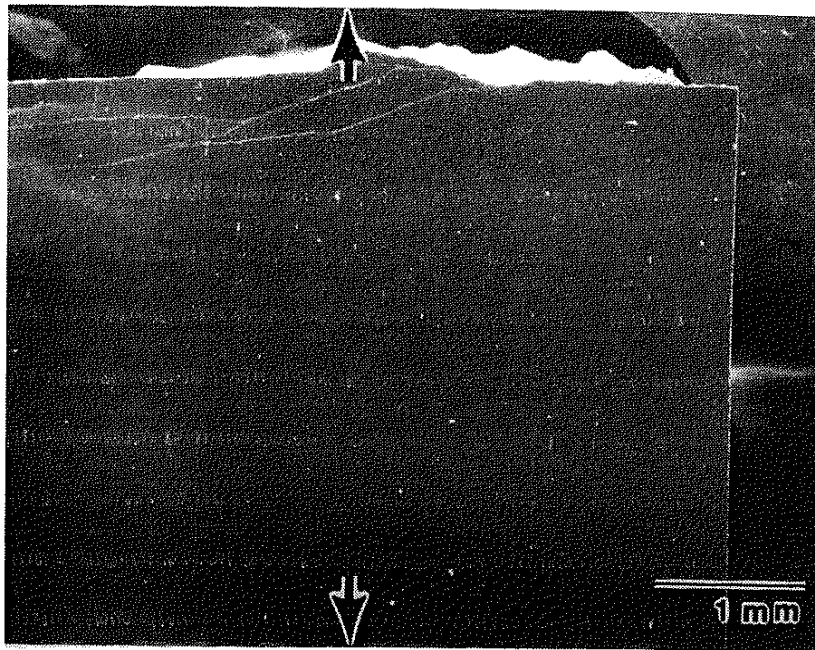
Figure 23 SEM micrographs of the axially sectioned view in fractured specimens under different loading conditions at room temperature. (A) static loading ($\sigma_{\max} = 234.4$ MPa) and (B) cyclic loading ($\sigma_{\max} = 220.6$ MPa, 2 Hz). (Arrows indicate the loading direction.)

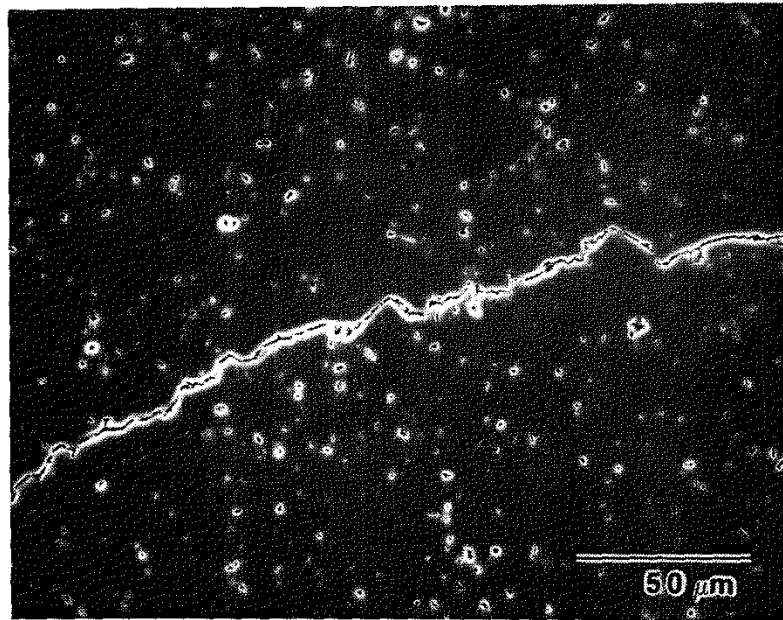
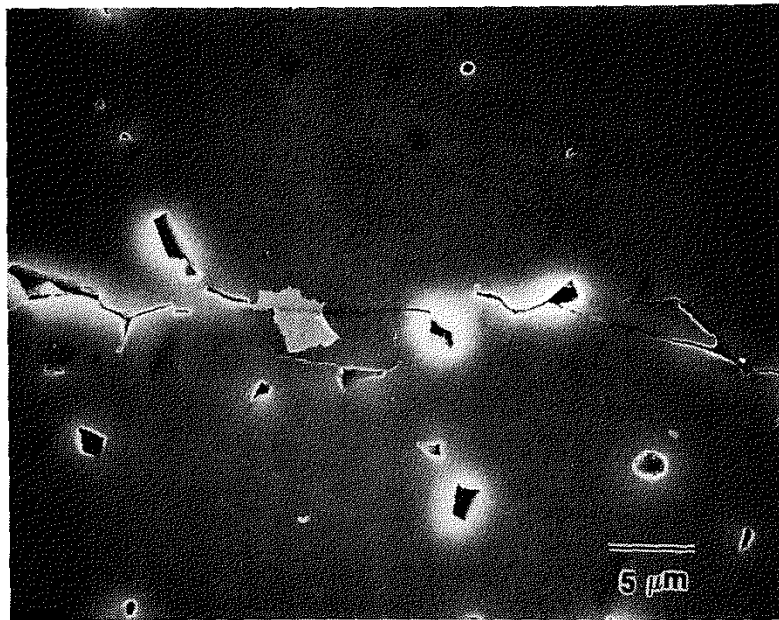
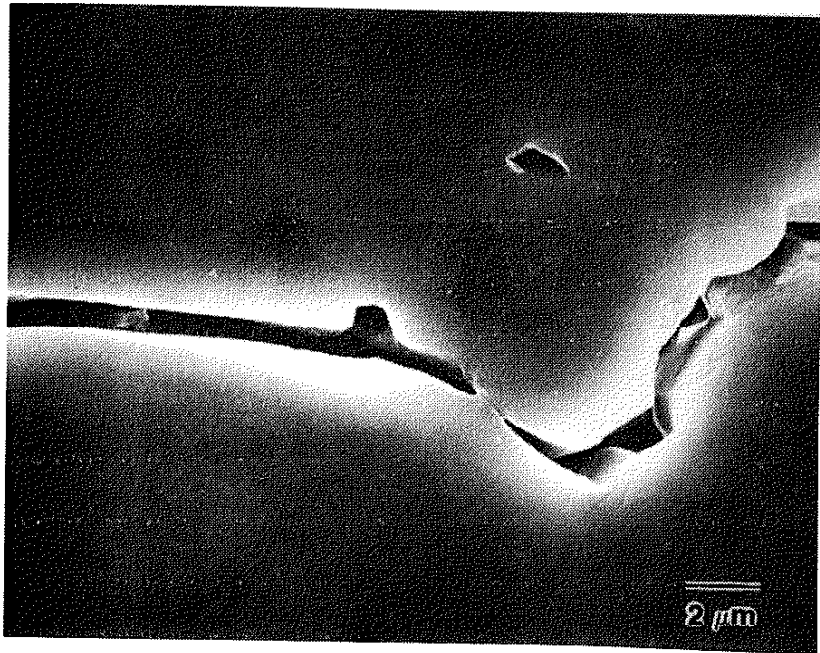
Figure 24 Some typical features observed along the crack paths in room temperature cyclic fatigue specimens. (A) crack deflection, (B) interlocking grains, (C) contact of fracture surface asperities, (D) an unbroken ligament, and (E) trapped grains within the closed crack.

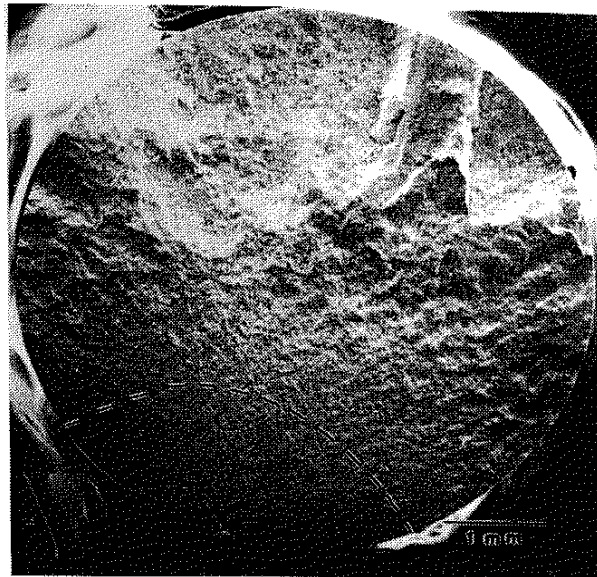
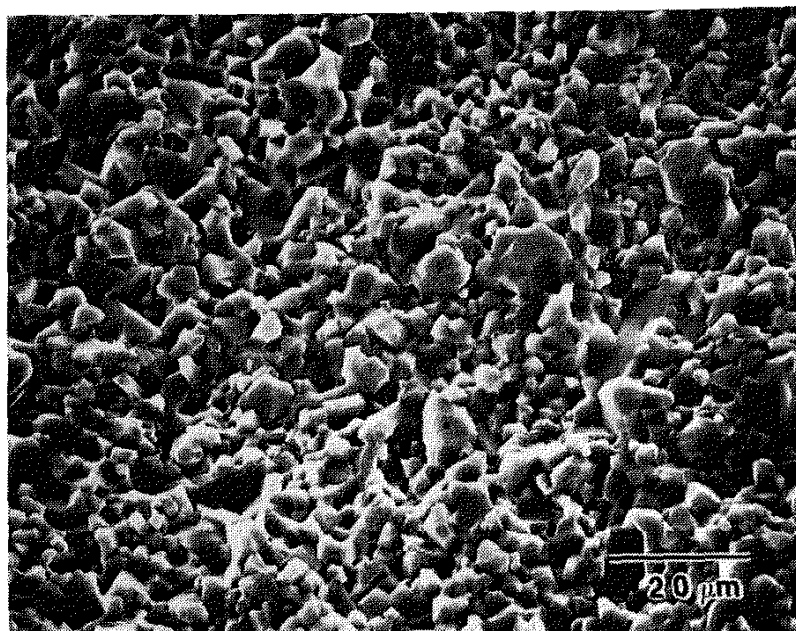
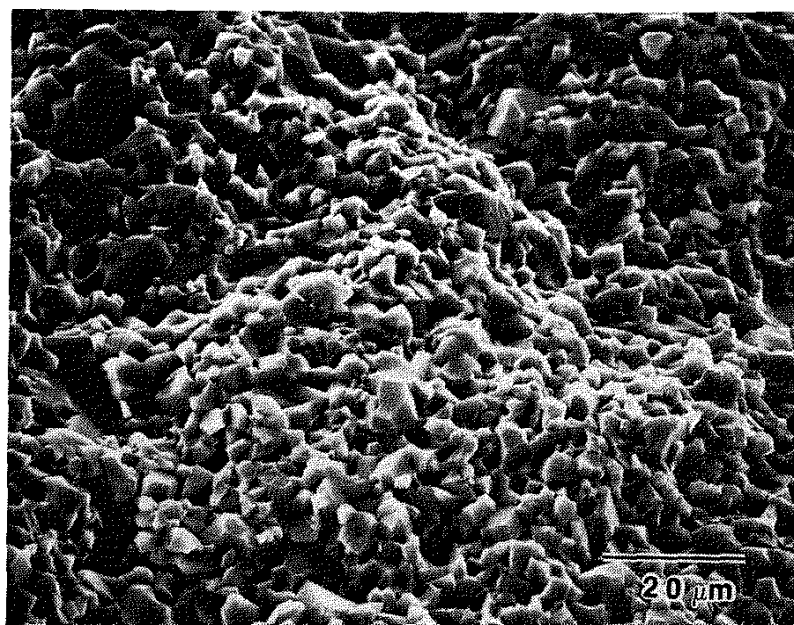
Figure 25 SEM micrographs demonstrating the typical fracture surface in sine wave form specimens failed at 1200°C. (A) macroscopic view, (B) high magnification view in the slow crack growth region, and (C) high magnification view in the fast fracture zone. ($\sigma_{\max} = 86.2$ MPa)

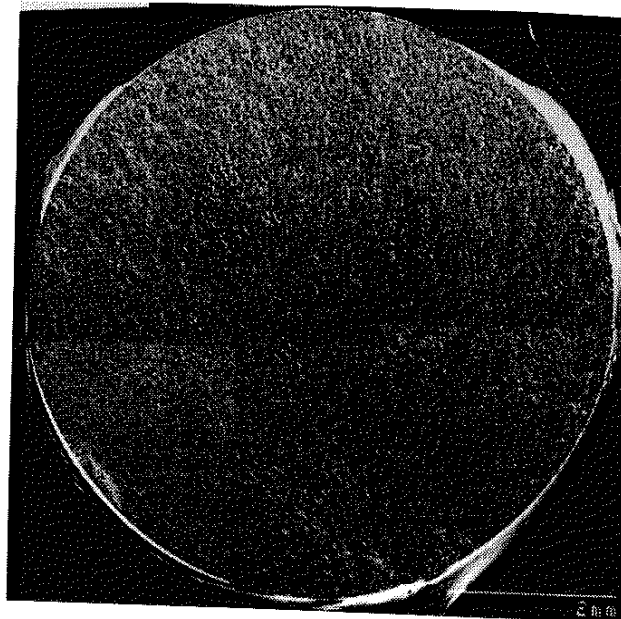
Figure 26 Macroscopic SEM view of the typical fracture surface in square wave form specimens ($R = 0.1$) failed at 1200°C . ($\sigma_{\text{max}} = 86.2 \text{ MPa}$)

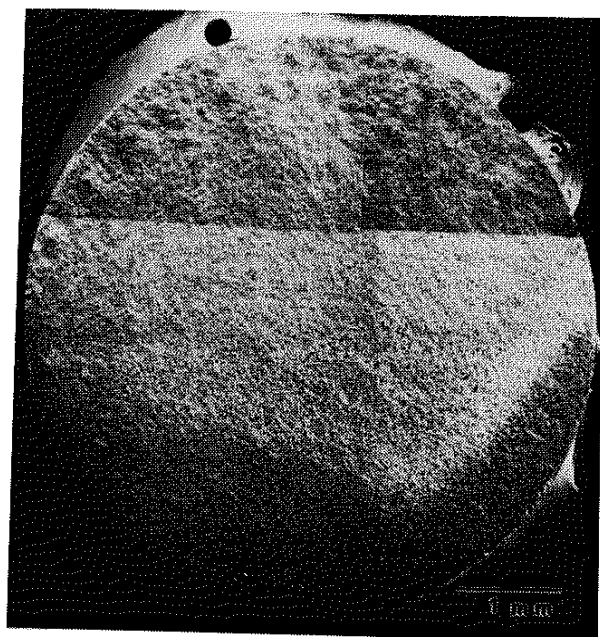
Figure 27 Macroscopic SEM view of the typical fracture surface in square wave form specimens ($R = 0.5$) failed at 1200°C . ($\sigma_{\text{max}} = 48.3 \text{ MPa}$)

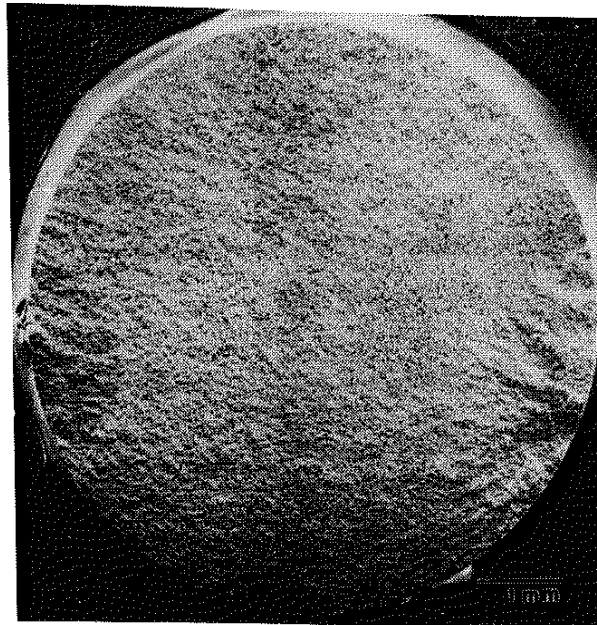
Figure 28 Macroscopic SEM view of the typical fracture surface in trapezoid I wave form specimens failed at 1200°C. ($\sigma_{\max} = 86.2$ MPa)

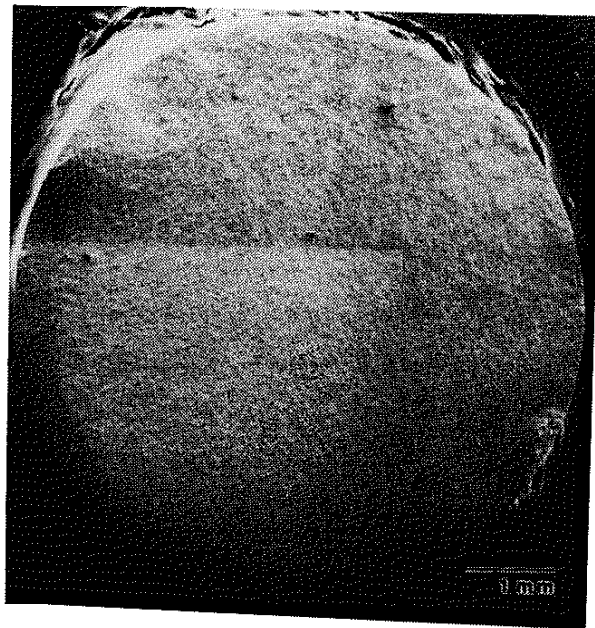
Figure 29 Macroscopic SEM view of the typical fracture surface in trapezoid II wave form specimens failed at 1200°C. ($\sigma_{\max} = 34.5$ MPa)

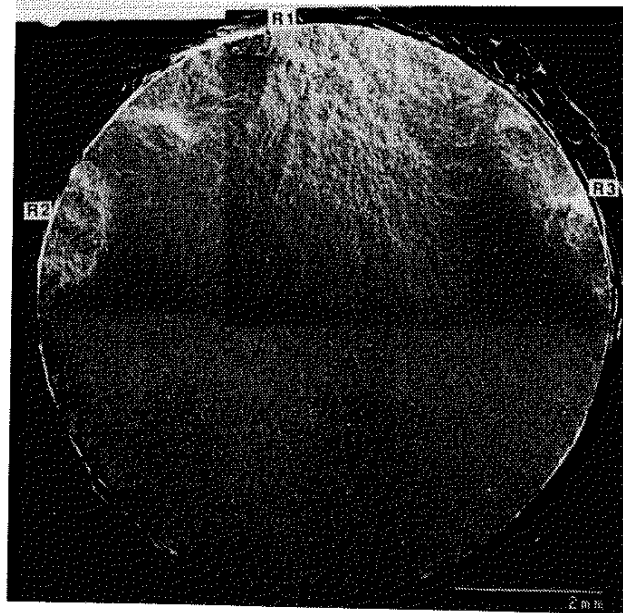
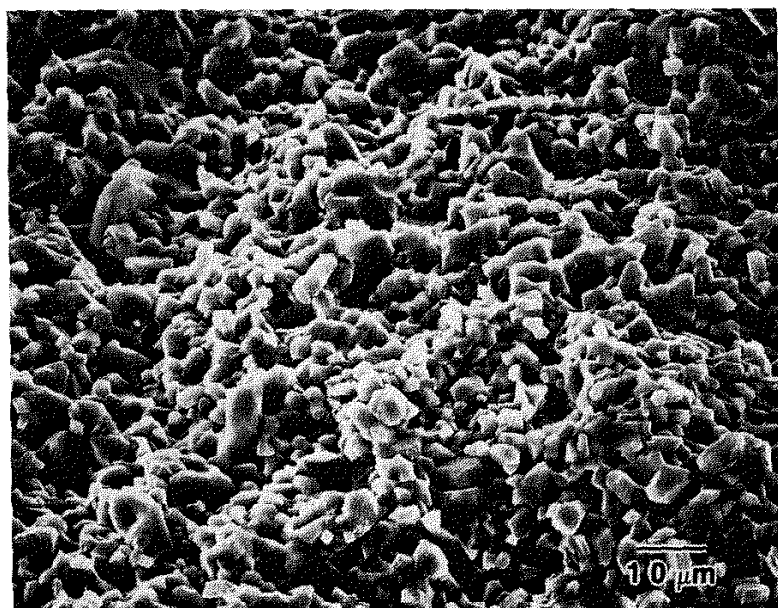
Figure 30 SEM micrographs demonstrating the typical fracture surface in static loading specimens failed at 1200°C. (A) macroscopic view, (B) high magnification view in the slow crack growth region, and (C) high magnification view in the fast fracture zone. ($\sigma_{\max} = 34.5$ MPa)

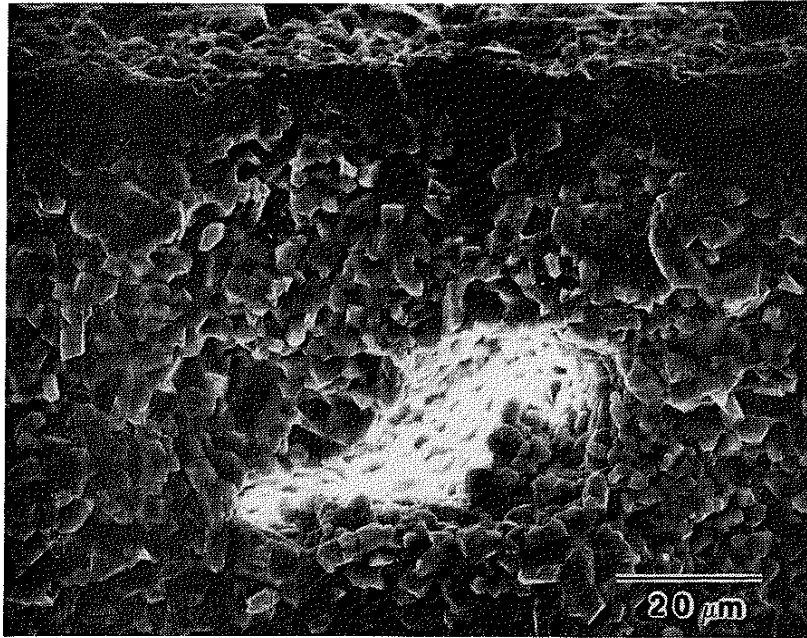
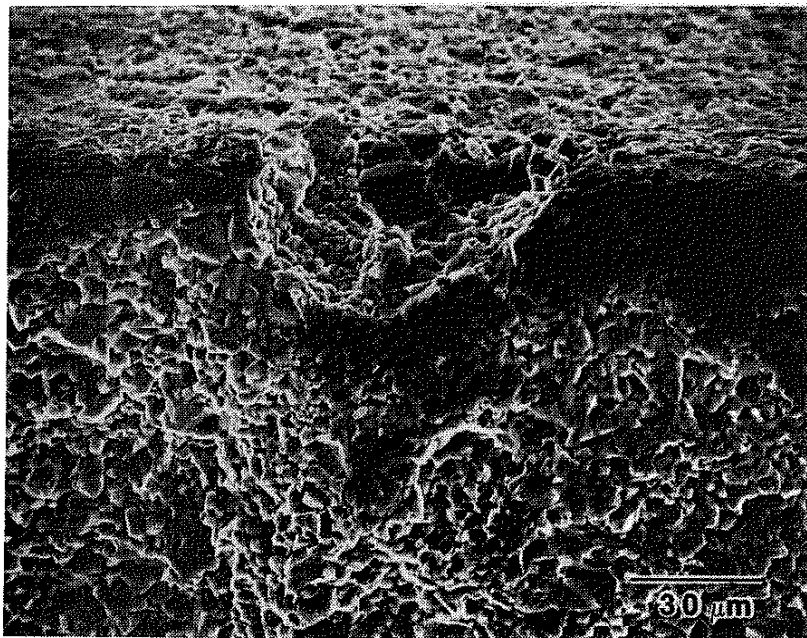
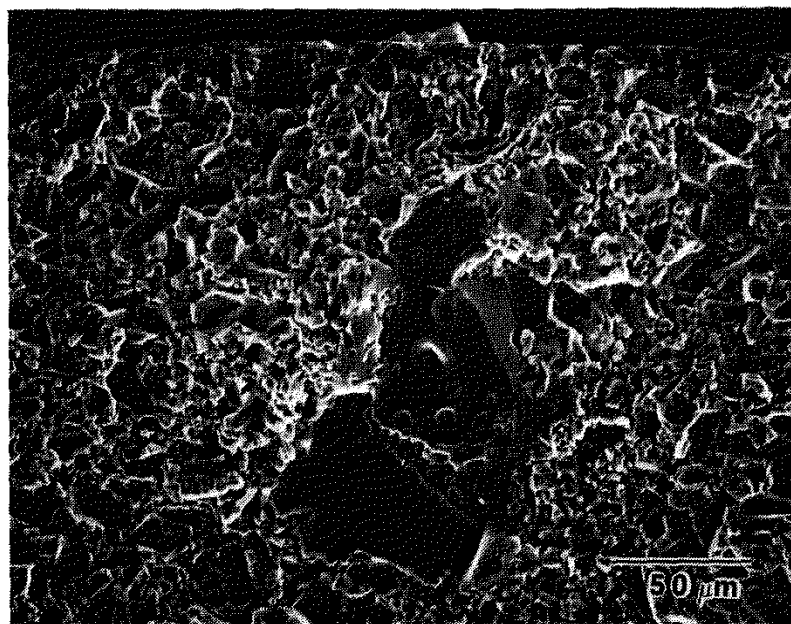
Figure 31 Typical failure origins at all applied loading conditions at 1200°C. (A) a large void near the edge of the fracture surface (square, $R = 0.1$, $\sigma_{\max} = 58.6$ MPa), (B) a large surface flaw (sine, $\sigma_{\max} = 86.2$ MPa), and (C) a large-grained agglomerate (static loading, $\sigma_{\max} = 34.5$ MPa).

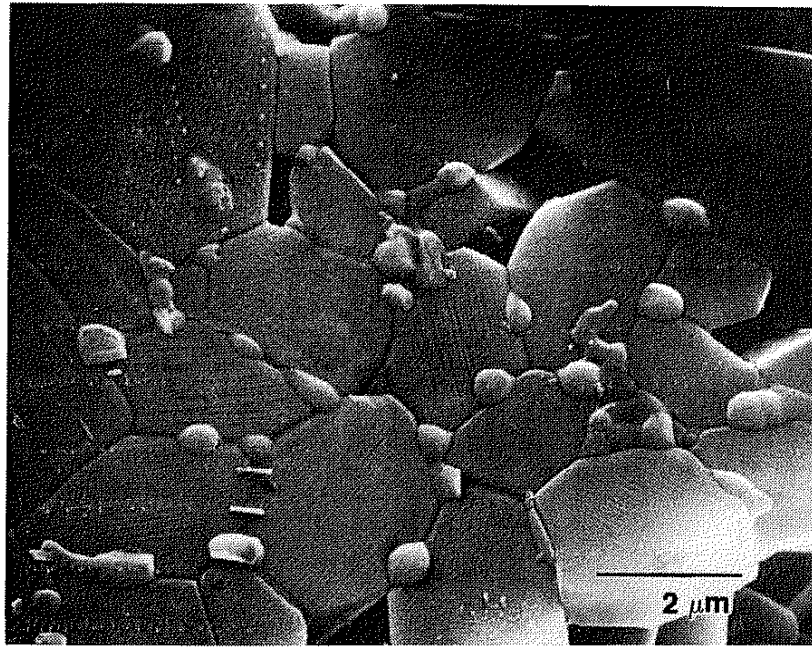
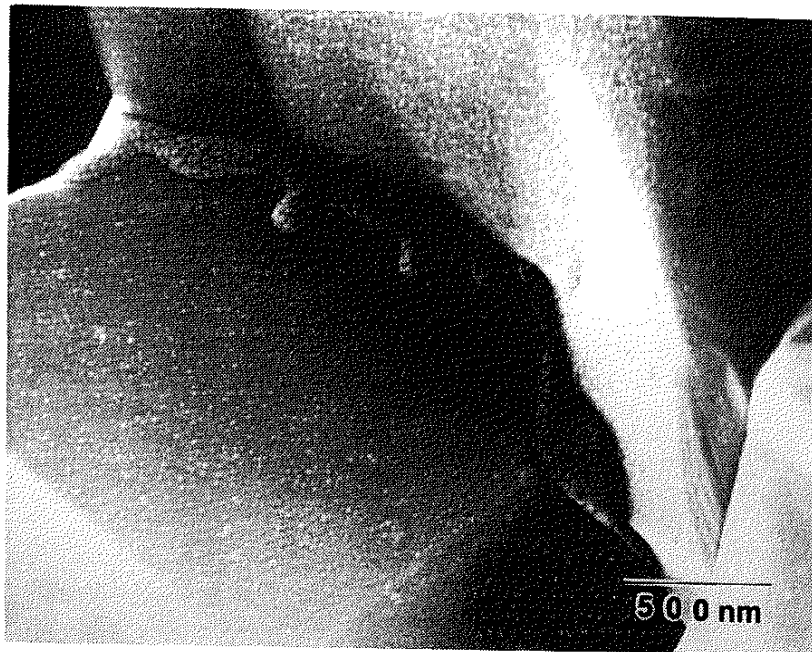
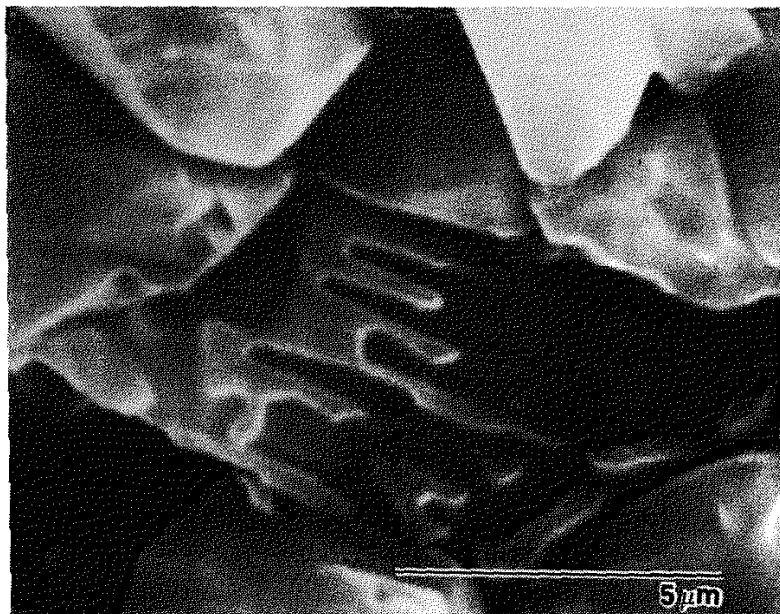
Figure 32 Typical profiles of the glassy phase on fracture surface in different loading conditions at 1200°C. (A) sine wave form ($\sigma_{\max} = 86.2$ MPa), (B) trapezoid II wave form ($\sigma_{\max} = 34.5$ MPa), and (C) static loading, ($\sigma_{\max} = 34.5$ MPa).

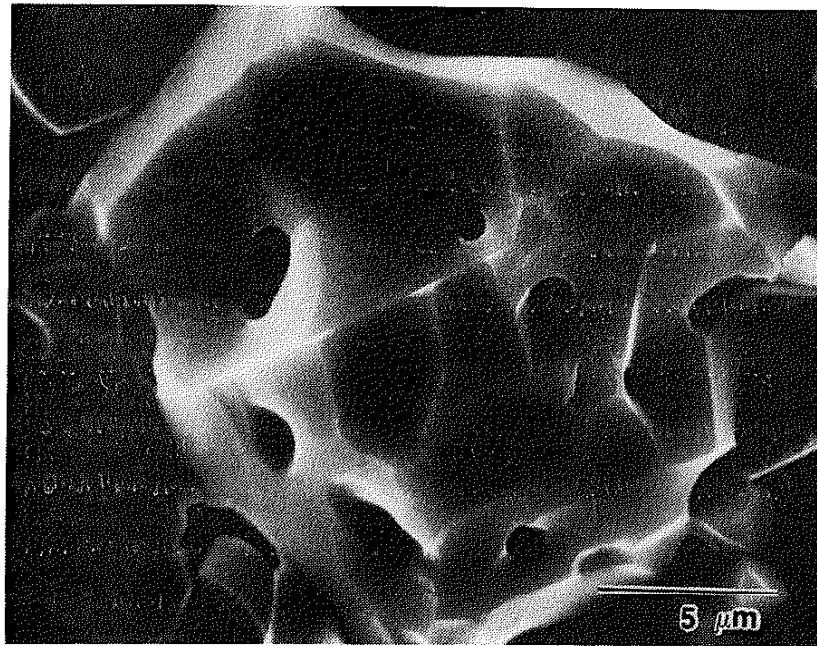
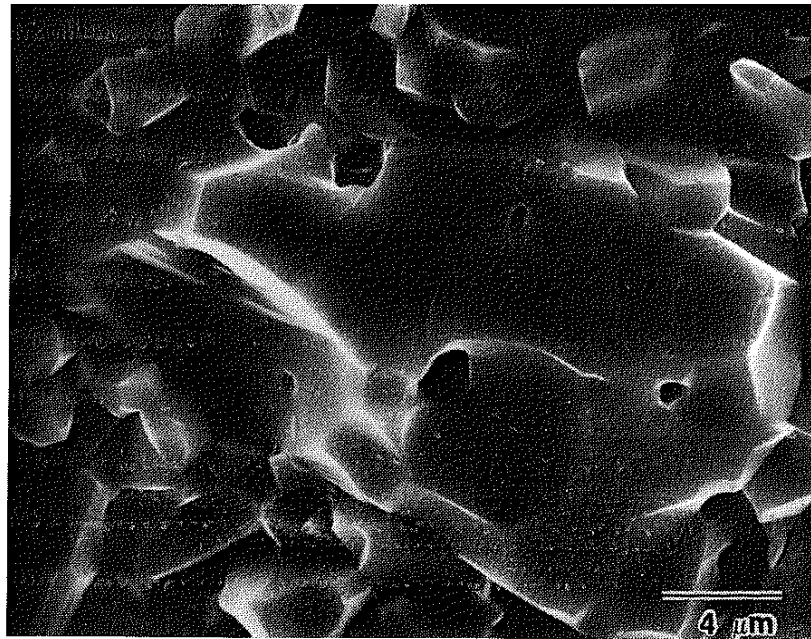
Figure 33 Comparison of the SEM micrographs of the grain facets in the areas without glassy phase on the fracture surface in the (A) room and (B) high temperature specimens.

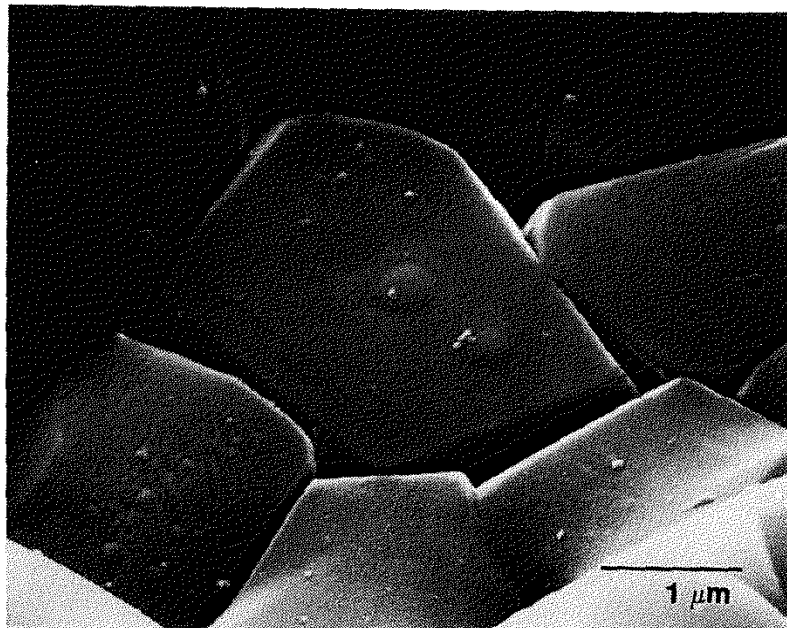
Figure 34 Evidence of grain-boundary sliding from the SEM micrograph of a trapezoid II wave form specimen failed with $\sigma_{\max} = 34.5$ MPa at 1200°C.

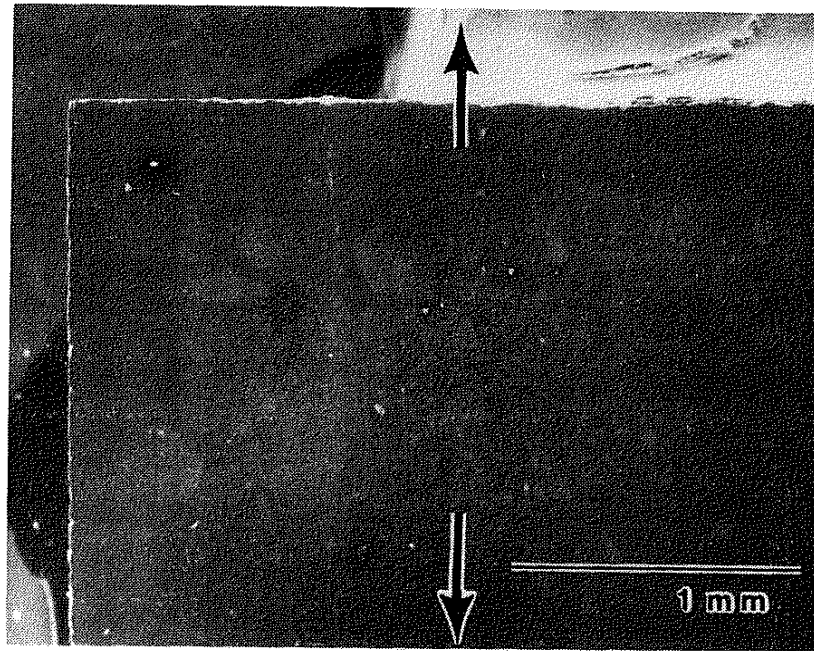
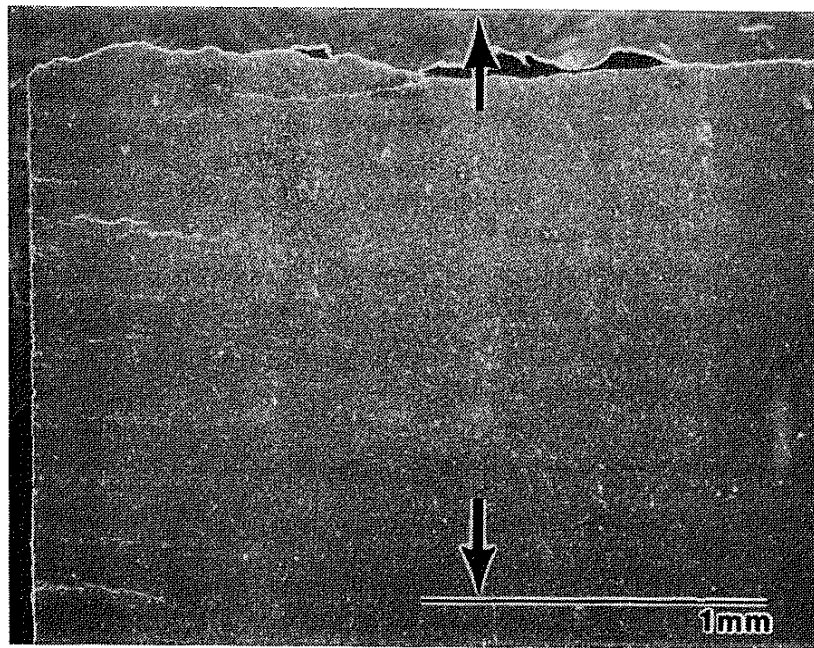
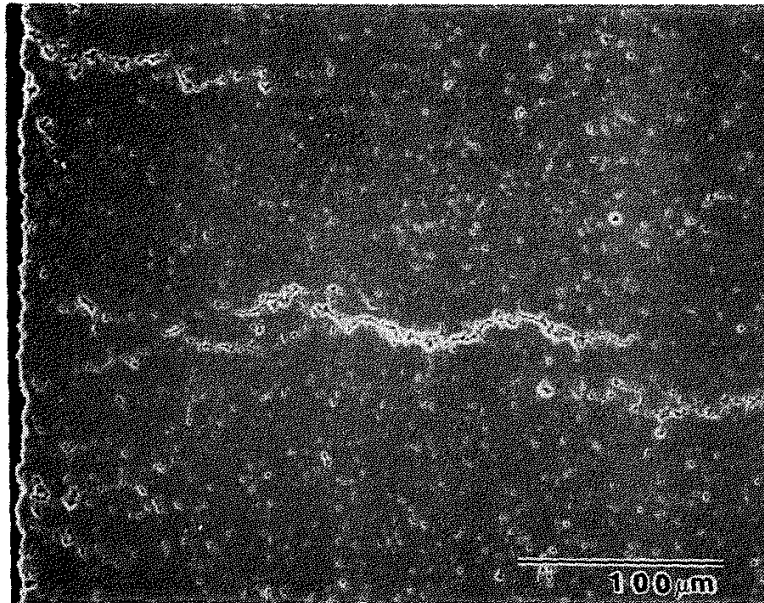
Figure 35 SEM micrographs of the axially sectioned view in fractured specimens under different loading conditions at 1200°C. (A) sine wave form ($\sigma_{\max} = 62$ MPa), (B) static loading ($\sigma_{\max} = 34.5$ MPa), (C) high magnification view of the non-failure-induced macrocracks in (B), and (D) the area around the crack tip of a non-failure-induced macrocrack in (C). (Arrows indicate the loading direction.)

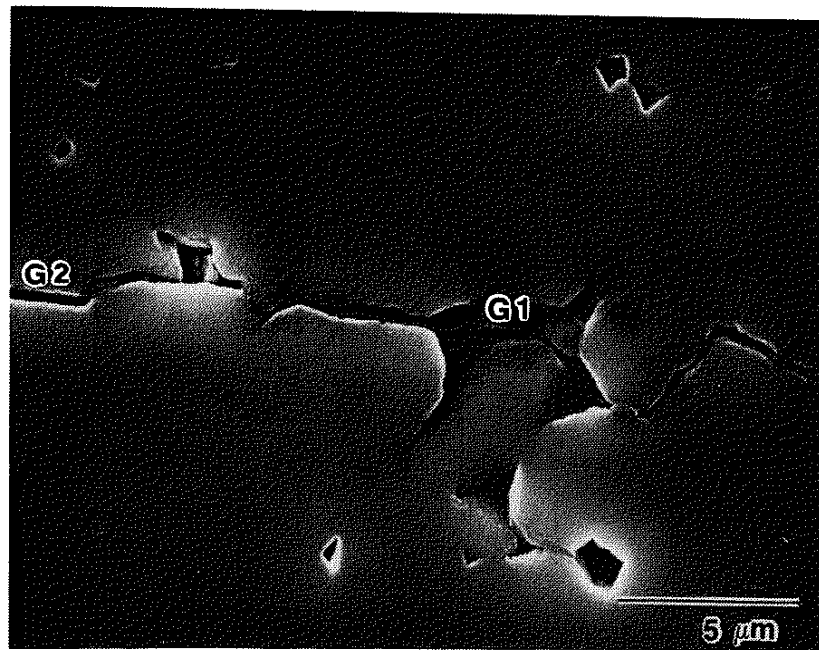
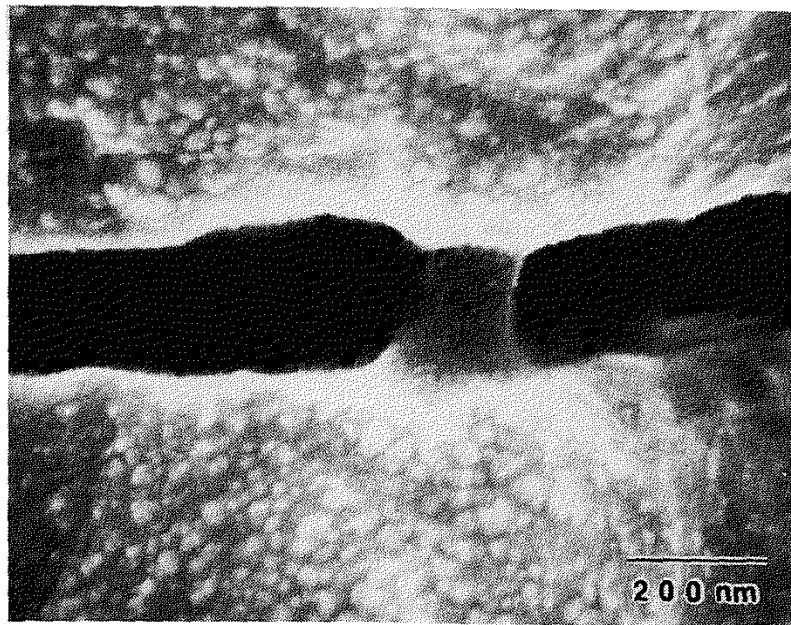
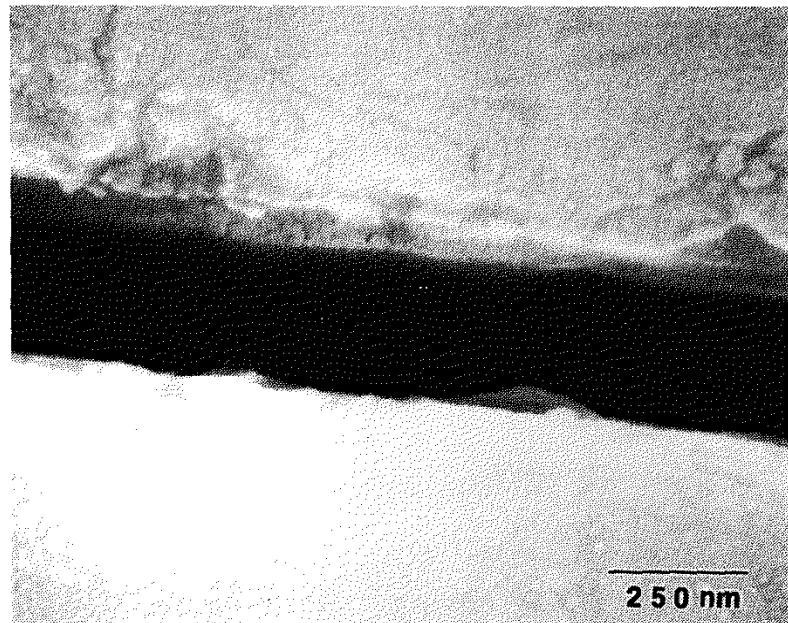
Figure 36 High magnification SEM view of the crack profile in an axially-cut section of a static loading specimen ($\sigma_{\max} = 34.5$ MPa) failed at 1200°C. (A) typical crack path, (B and C) enlarged views showing the viscous glassy phases bridging the crack surfaces at marked segments, G1 and G2, respectively, in (A).
