UILU-ENG 91-3601

Report No. 155

**FATIGUE OF ALUMINA
AT ROOM AND HIGH TEMPERATURES**

A Report of the
MATERIALS ENGINEERING—MECHANICAL BEHAVIOR
College of Engineering, University of Illinois at Urbana-Champaign
October 1991

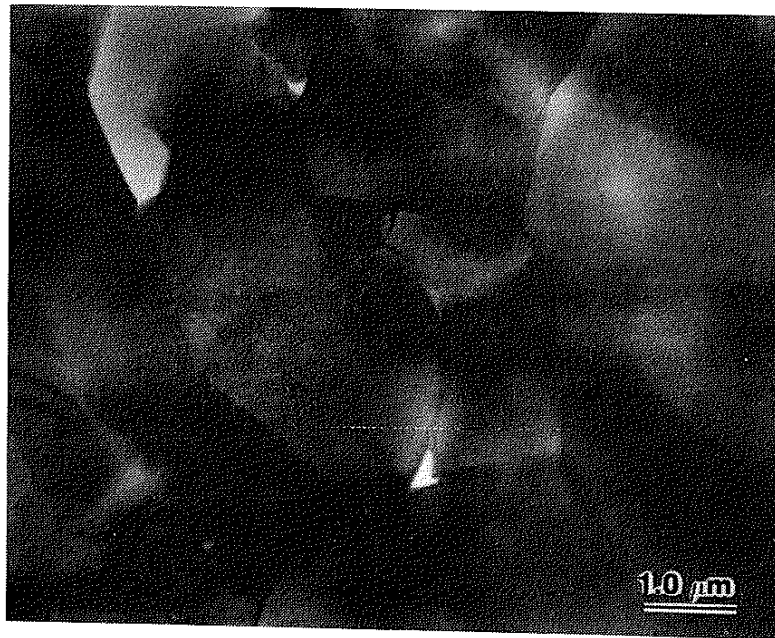
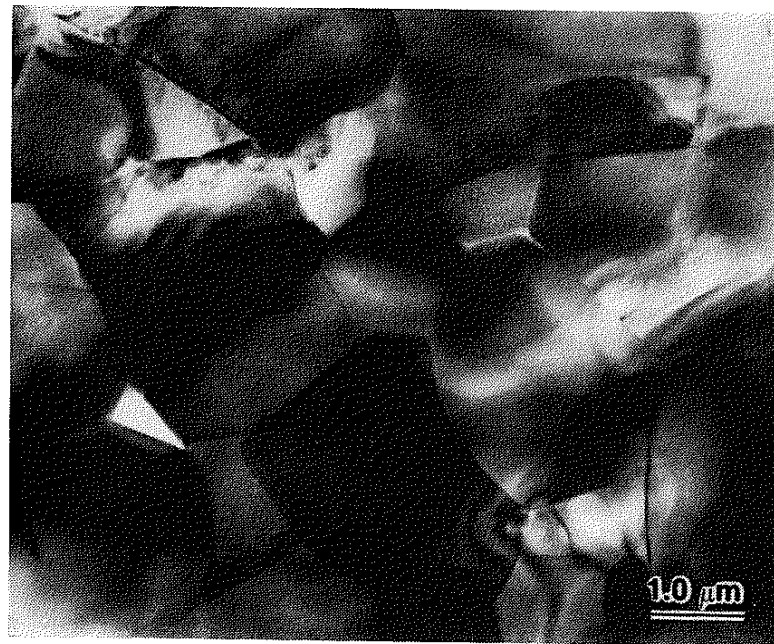
Figure 37 TEM micrographs of the general structure after failure in room temperature (A) static and (B) cyclic fatigue specimens.

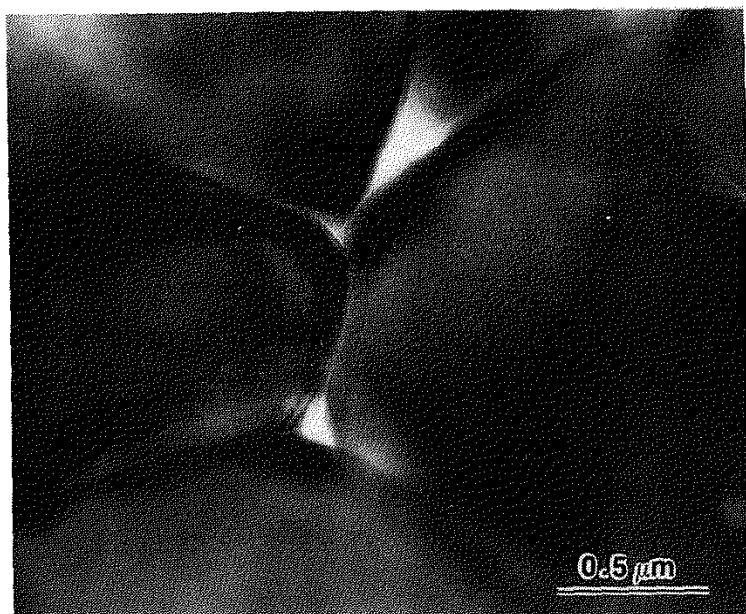
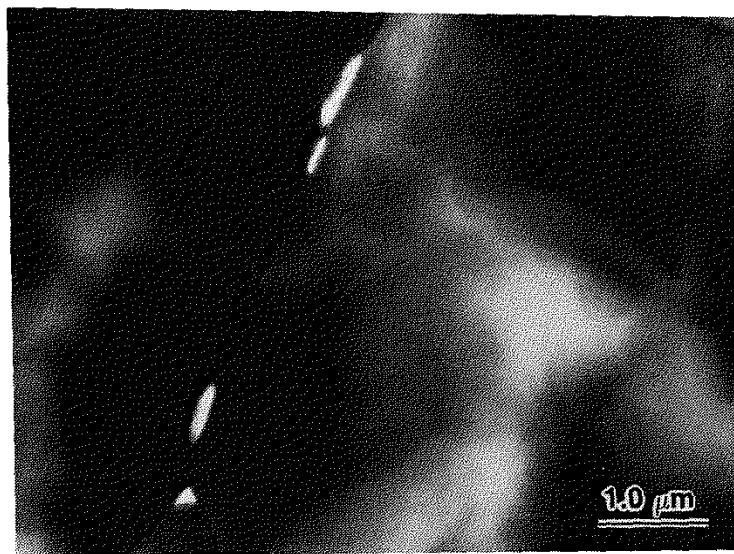
Figure 38 TEM micrographs demonstrating (A) growth and linkage of pores in a static loading specimen ($\sigma_{\max} = 34.5$ MPa) and (B) isolated pores (no linkage of pores was observed) in a sine wave form specimen ($\sigma_{\max} = 62$ MPa).

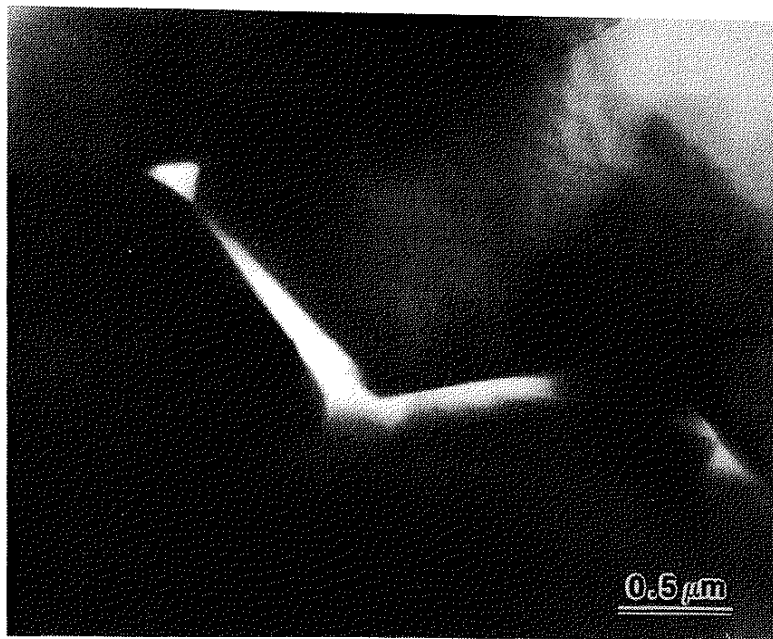
Figure 39 Evidence of grain-boundary sliding in the TEM micrograph of a static loading specimen failed with $\sigma_{\max} = 34.5$ MPa at 1200°C.

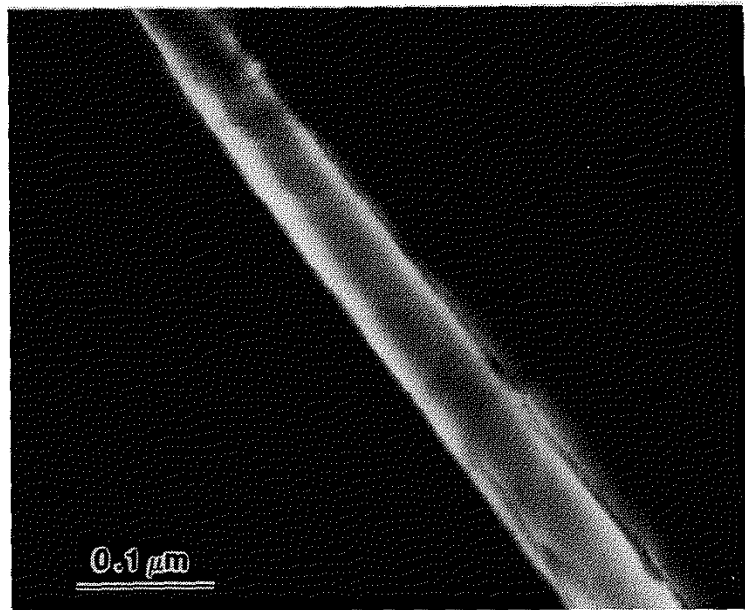
Figure 40 TEM micrograph showing a side view of the finger-like meniscus of the viscous glassy phase between two alumina grains.

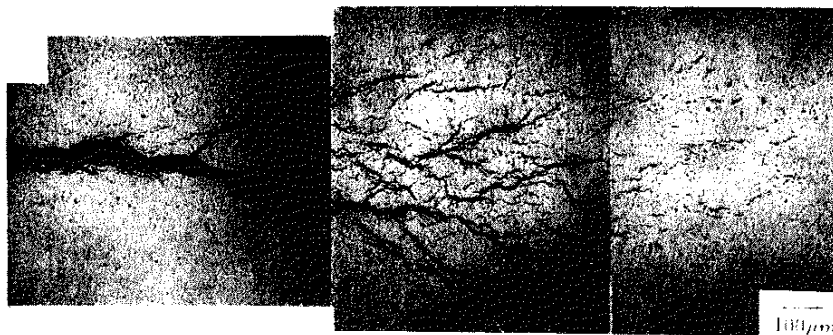
Figure 41 A damage zone of distributed microcracking ahead of a long fatigue crack in an Al_2O_3 -33 vol.% SiC whisker composite subjected to cyclic tensile loads (in four-point flexure) in 1500°C air environment. (From Ref. 62)

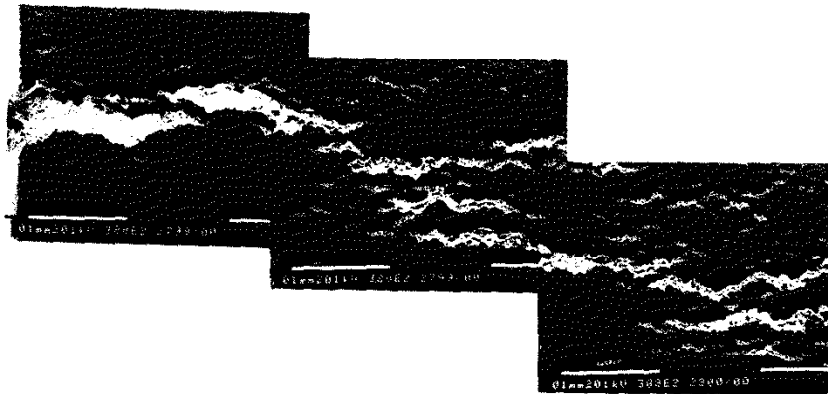
Figure 42 Microcrack coalescence through shear band formation on the tensile surface of a bend bar of AVCO alumina deformed at 100 MPa and 1150°C. Bars = 0.1 mm. (From Ref. 82)

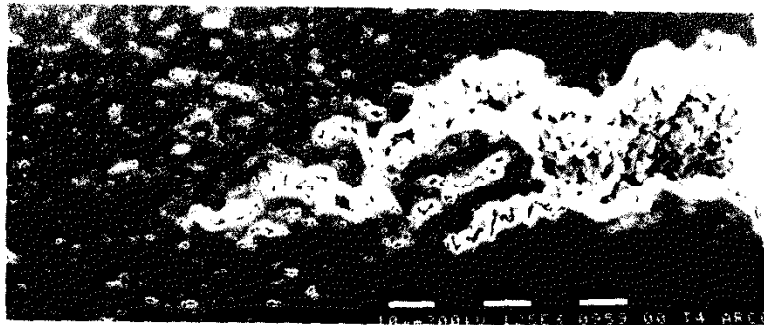
Figure 44 Microcracking and crack-tip blunting on an internal section of a tensile specimen of ARCO alumina deformed at 55 MPa and 1250°C. Bars = 10 μm . (From Ref. 82)

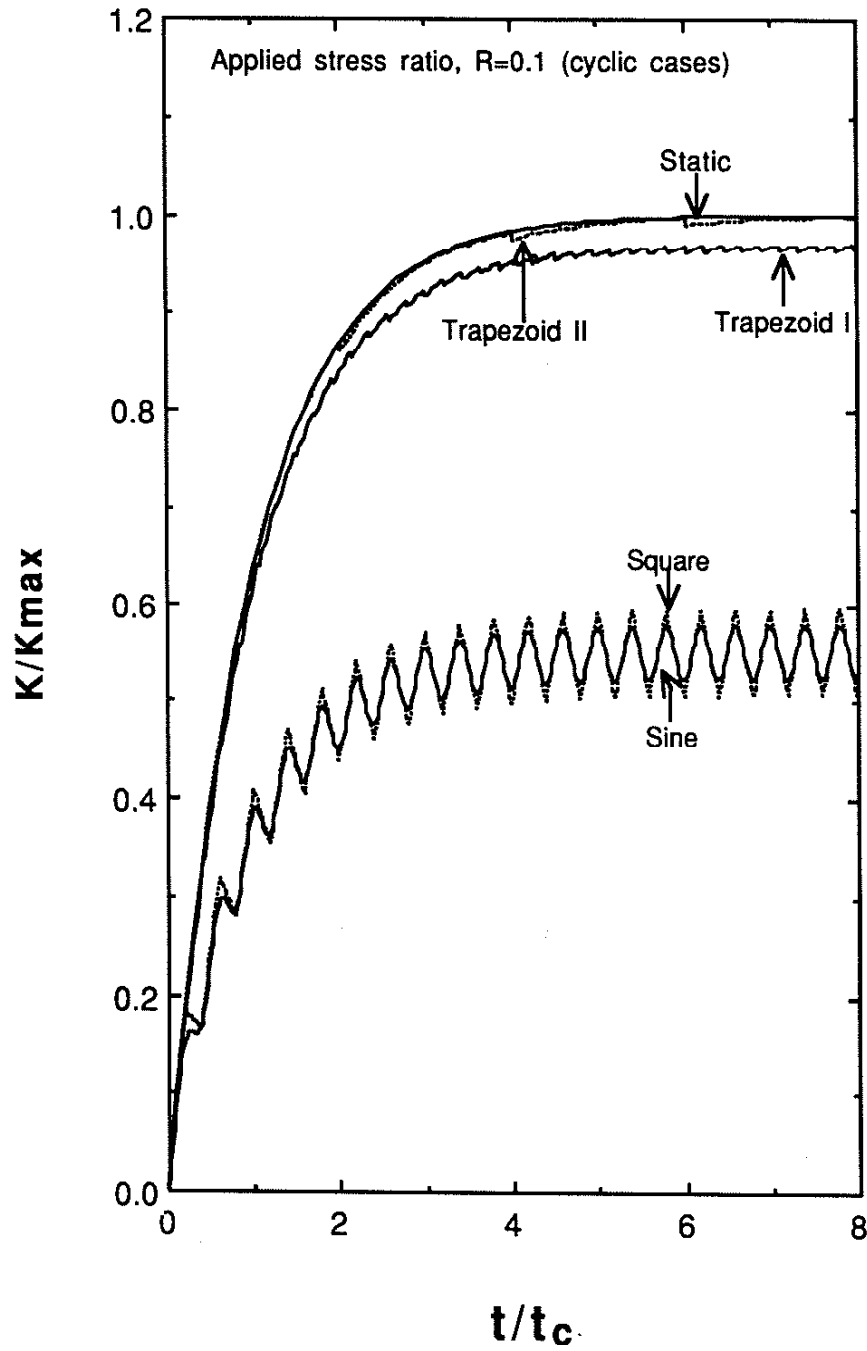
Figure 45 Comparison of the calculated effective stress intensity factors at the crack tip in static loading and various cyclic loading wave forms at 1200°C under the same maximum applied stress intensity factor, K_{max} .

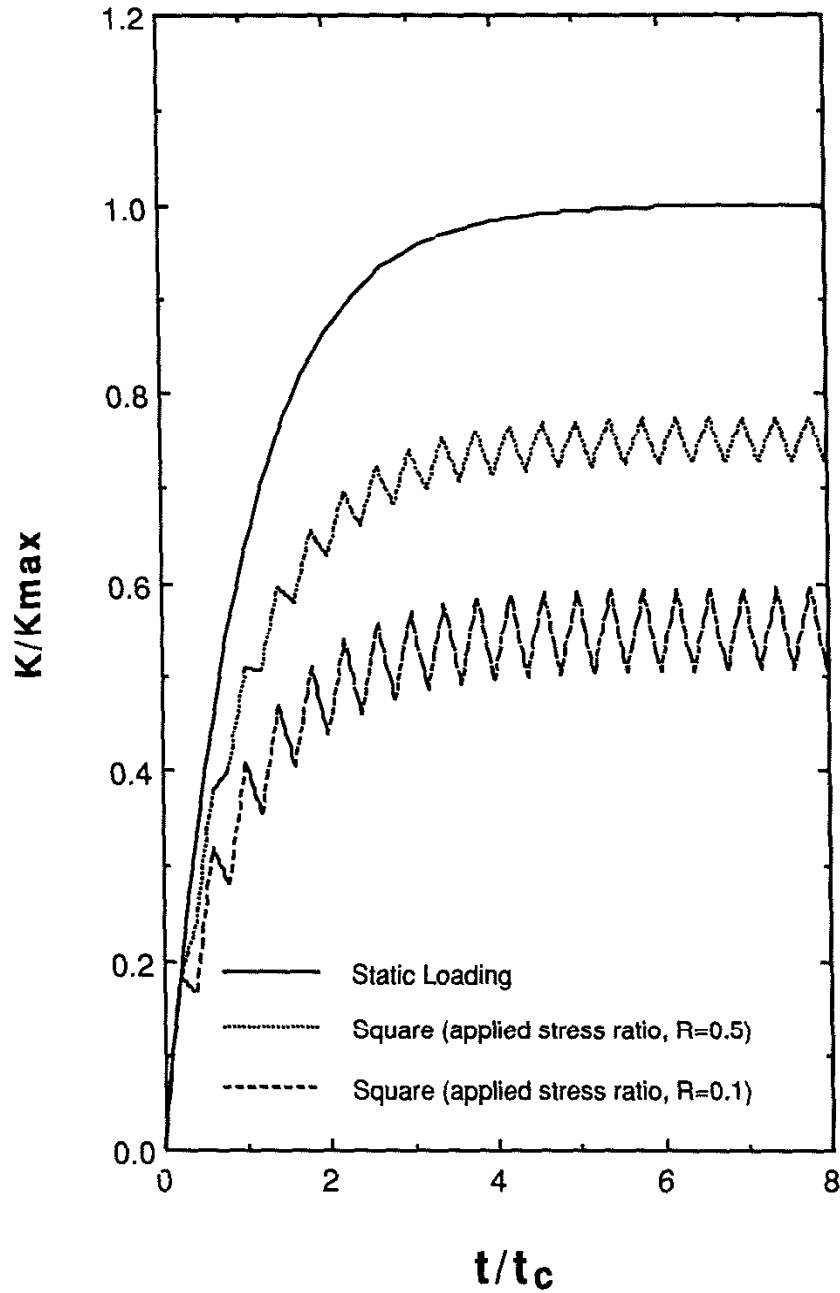
Figure 46 Comparison of the calculated effective stress intensity factors at the crack tip in static loading and square loading wave forms ($R = 0.1$ and 0.5) at 1200°C under the same maximum applied stress intensity factor, K_{max} .

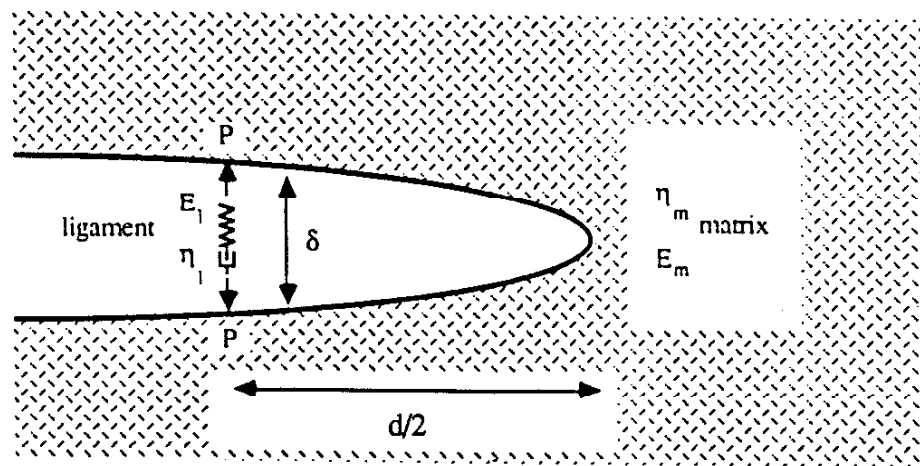
Figure A1 Geometry of the crack and ligament assumed for the bridging-zone model.
(From Ref. 103)
